# Flood Risk Assessment

**T00TING TRIANGLE  
366 CAVENDISH ROAD  
LONDON SW12 0PP  
February 2020**

**Flood risk assessment in support of a planning application for erection of rear and side extensions with installation of new roofing; installation of new doors; installation of new platforms with disabled access ramps; installation of new all weather football pitches with associated fencing and floodlights.**

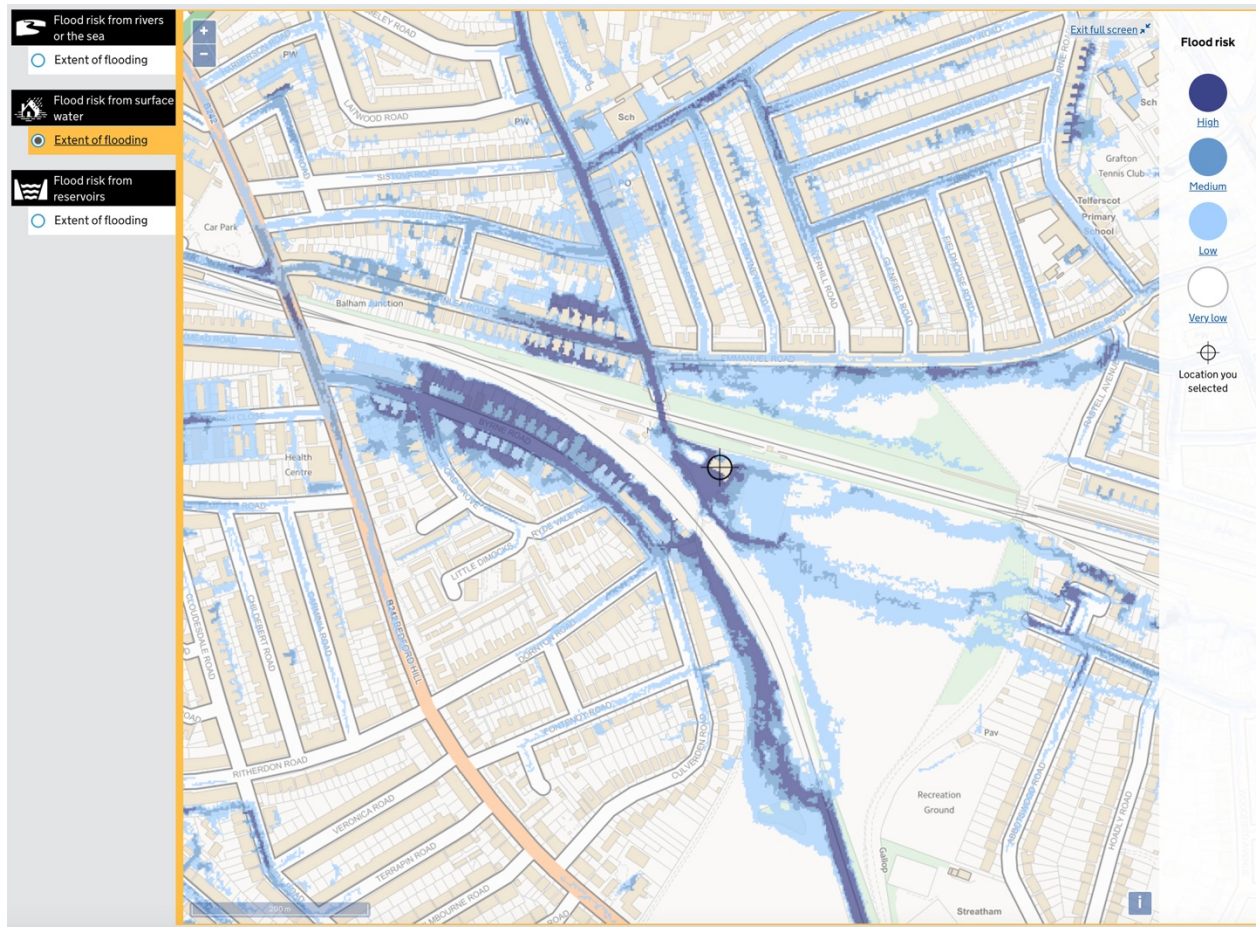
## 2.0 Assessment of known flooding

- 2.1** According to the Environment Agency data there is a known risk of surface water flooding at this site which is well confirmed by recent on site observations.

- 2.2** Observation 1. on 16 January 2020 following heavy overnight rain the football pitch, garden, play area and changing rooms to the Boxing Club were inundated. While water was going down the channel drain in the garden, it was not able to discharge fast enough to prevent the water penetrating the buildings.

- 2.3** Observation 2. on 11 February 2020 the garden and pitch was mostly clear of water, but the common to the east had areas of standing water and no capacity to hold any more.

- 2.4** Observation 3. on 13 February 2020 following heavy overnight rain the pitch was flooded and water was running in the garden and managing to escape via the channel drain. Water did briefly flood the floor of the changing rooms, then subsided. Water was observed running down the path at the northeast corner of the site constantly topping up the standing water on the pitch and in turn, flowing into the garden.

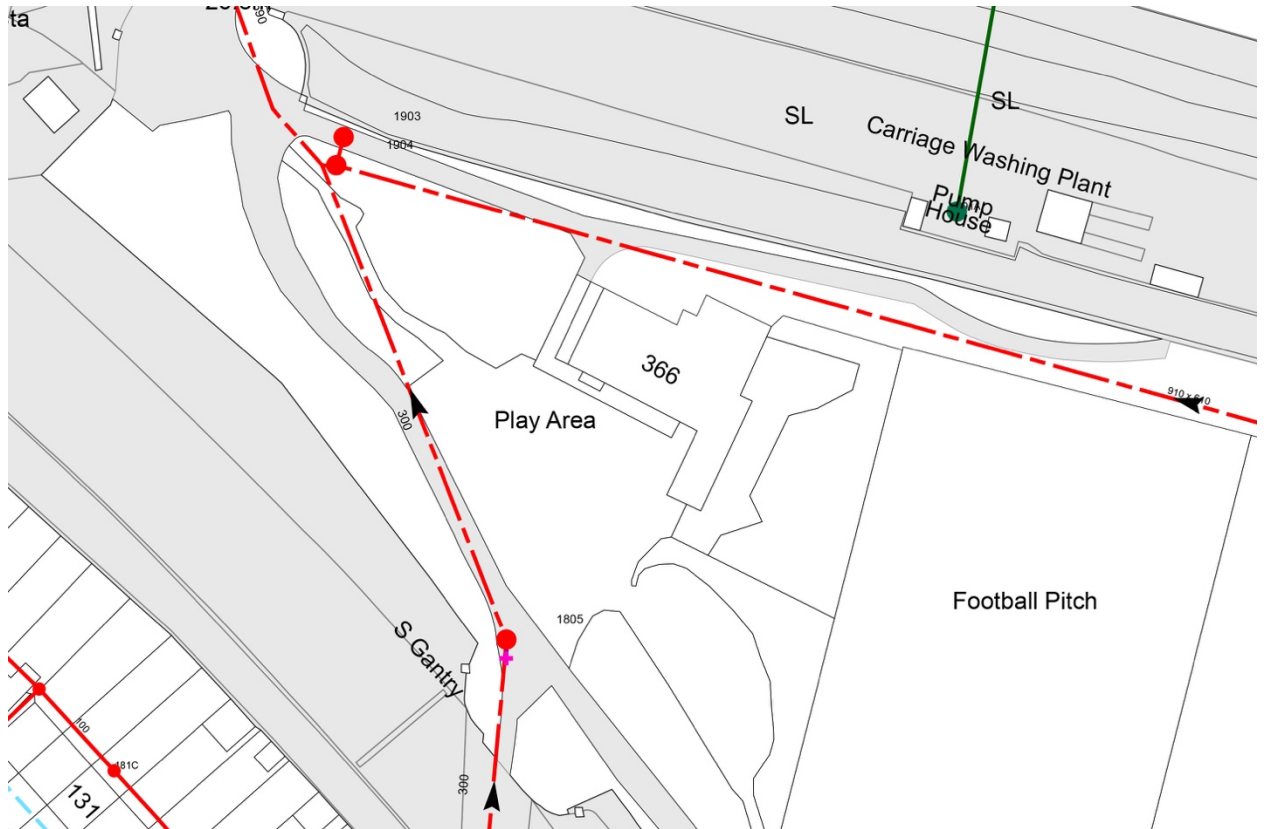
### Thames Water sewer map

- 4.1** Below ground there is substantial drainage capacity with a main carrier sewer running along the north side of the common and exiting towards Cavendish Road under the railway bridge. Also connecting to this is a 300mm diameter pipe running from the south side of the Triangle.
- 4.2** The drainage survey shows that the current 100mm foul drain from the buildings on the site connect to Thames Water's chamber no.1904 which has an invert level of 5.07 metres and feeds into a culvert measuring 1070mm x 690mm.
- 4.3** Because the 100mm foul drain is the only means of draining surface water currently an alternative higher capacity drain will be required or the flooding events will continue.
- 4.4** The proposed all weather sports pitches and stay and play facilities will not be able to operate during wet weather if the current drainage is not considerably improved.

- 4.5** It is proposed to run a large capacity 450mm diameter surface water drain to connect the deep level sewer running below the site and to bypass the current 100mm foul water drain.

- 4.9** The new 450mm surface water drain will connect to the 450mm land drain pipe and run a further 90 metres parallel to the path along the north side to connect to the Thames Water sewer chamber no.1904 located close to the entrance to the children's play area.
