BS 5837:2012 TREE SURVEY AND ARBORICULTURAL METHOD STATEMENT FOR TOOTING TRIANGLE 366 CAVENDISH ROAD LONDON

Prepared on behalf of:
TFC Leisure Ltd
Rocks Lane Multi Sports Centre
Rocks Lane
London
SW13 0DG

Ref: PB/5837-01/07.08

10th September 2019

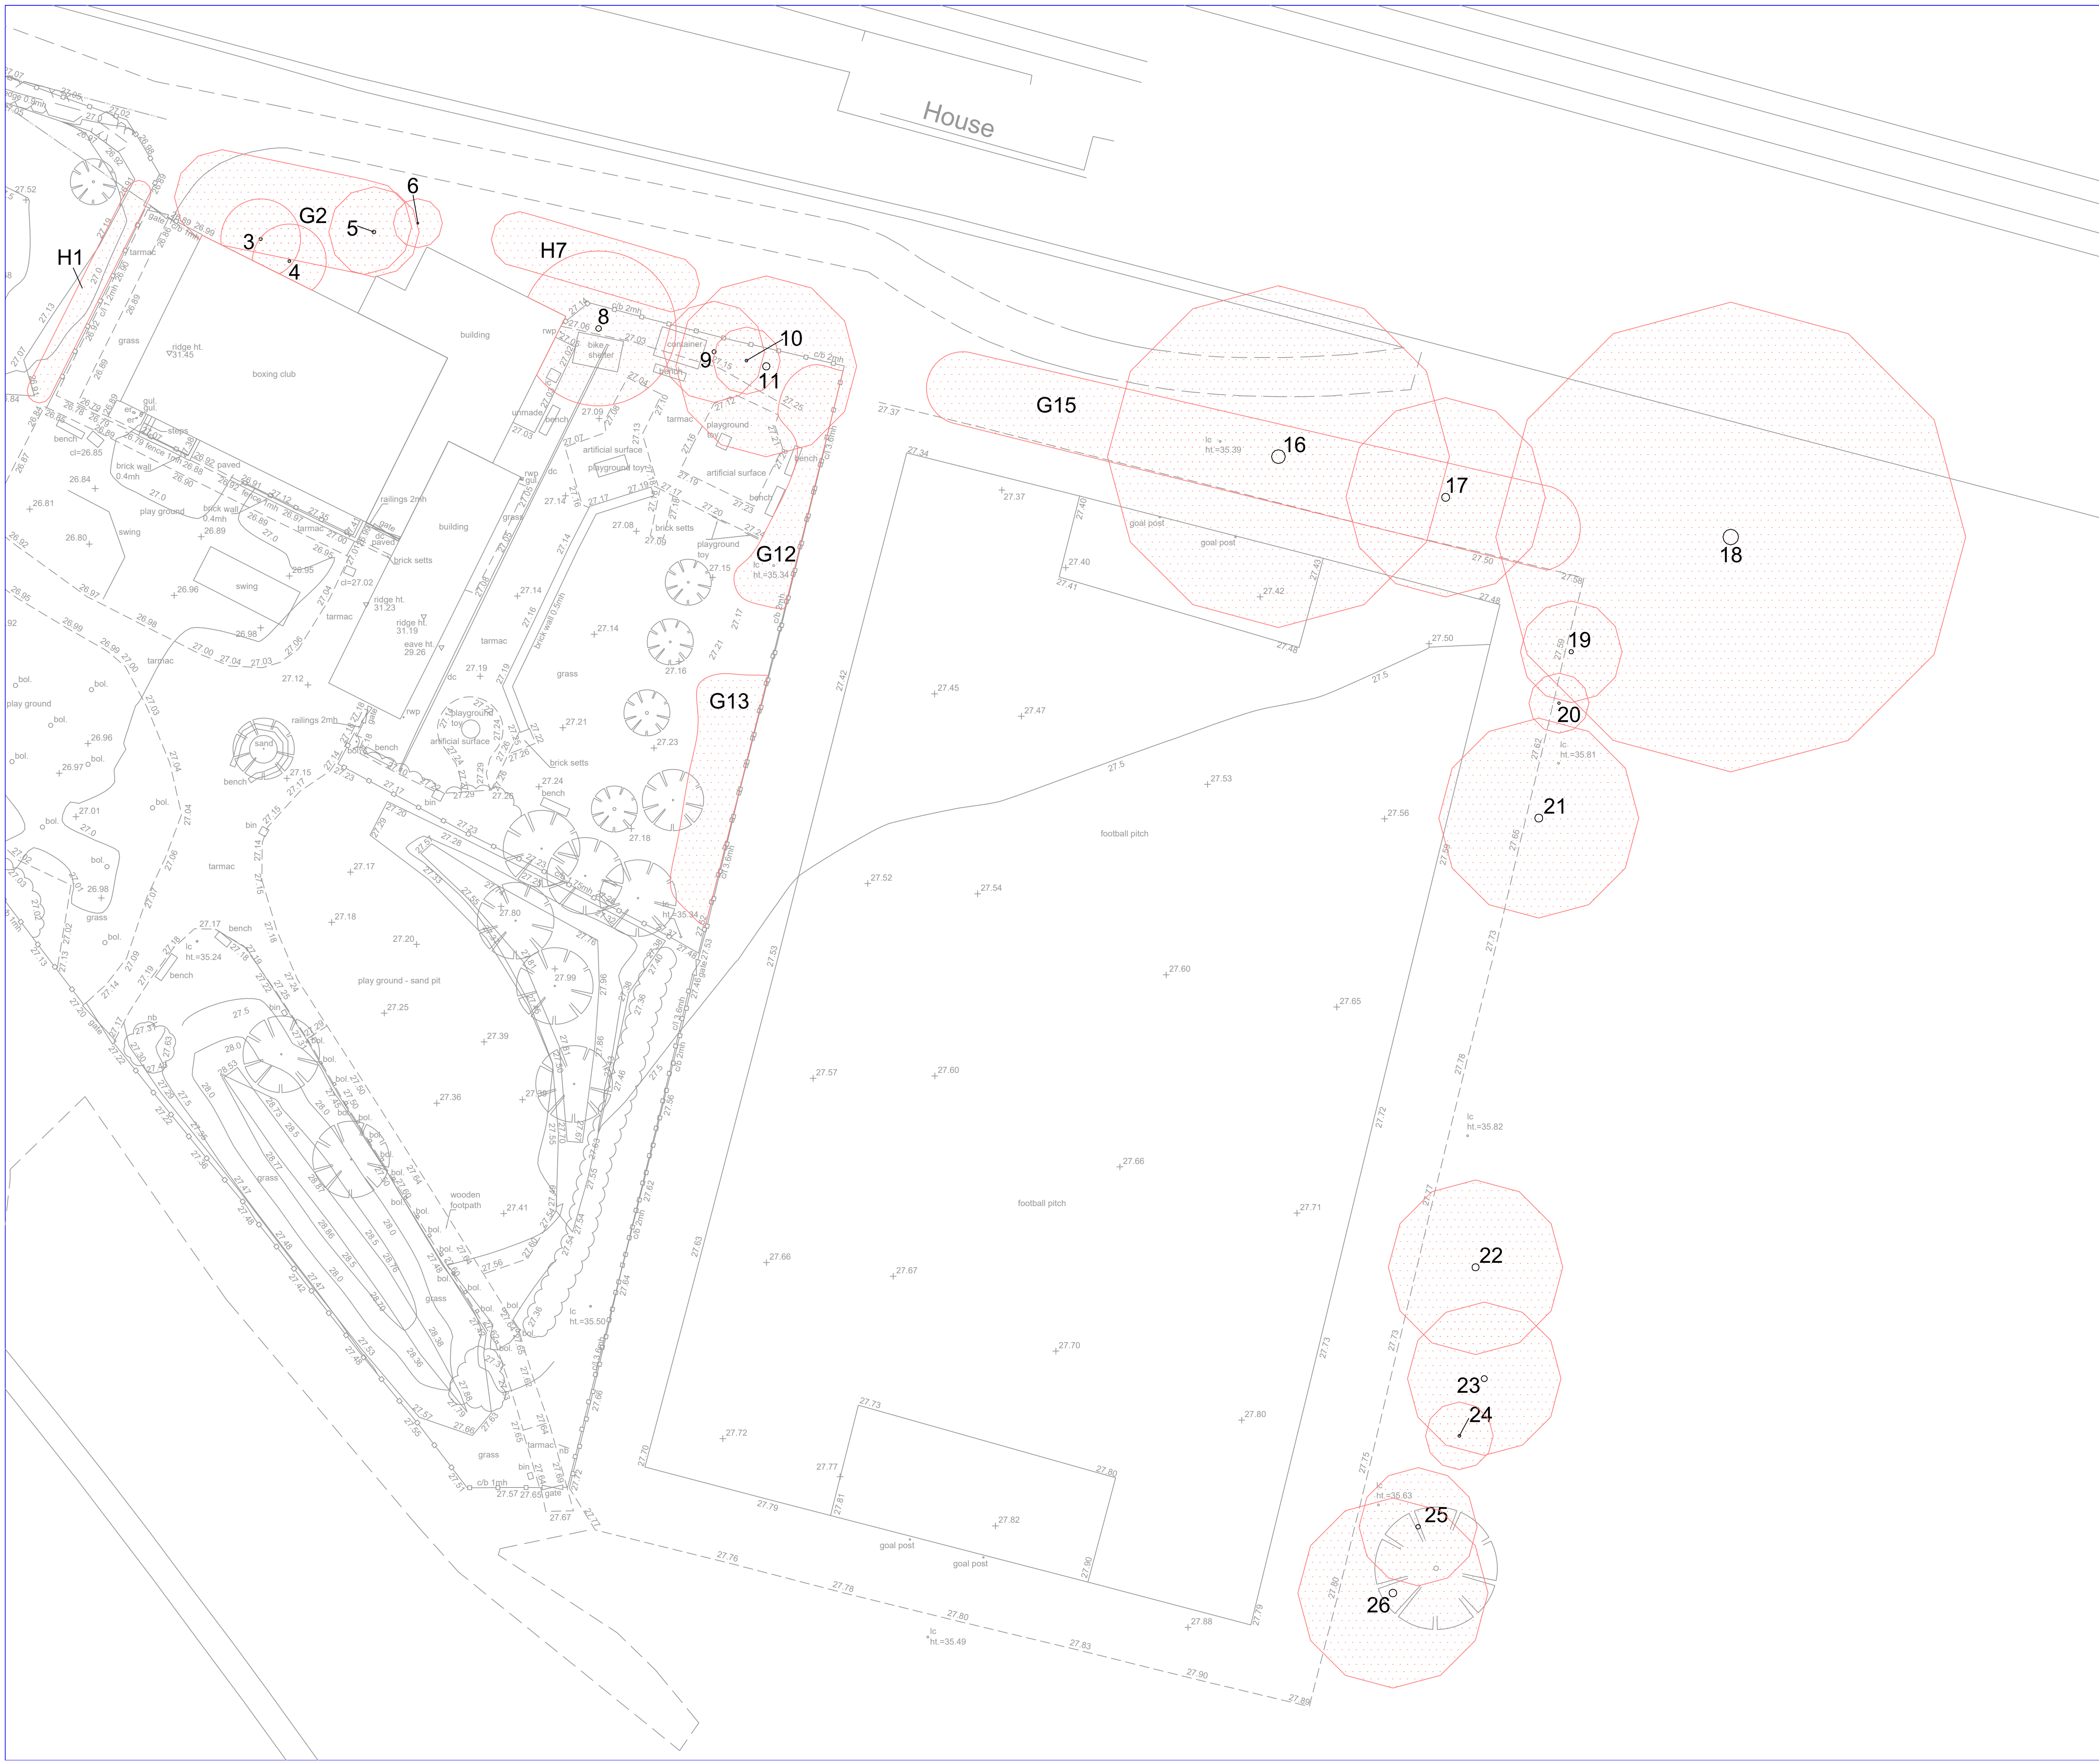
APPENDIX 3

Mitigation may be required to demonstrate how the retained trees' root protection areas (RPAs) will be protected during any development, including access to the proposed development area. The RPAs are shown on the drawing included at Appendix 3.

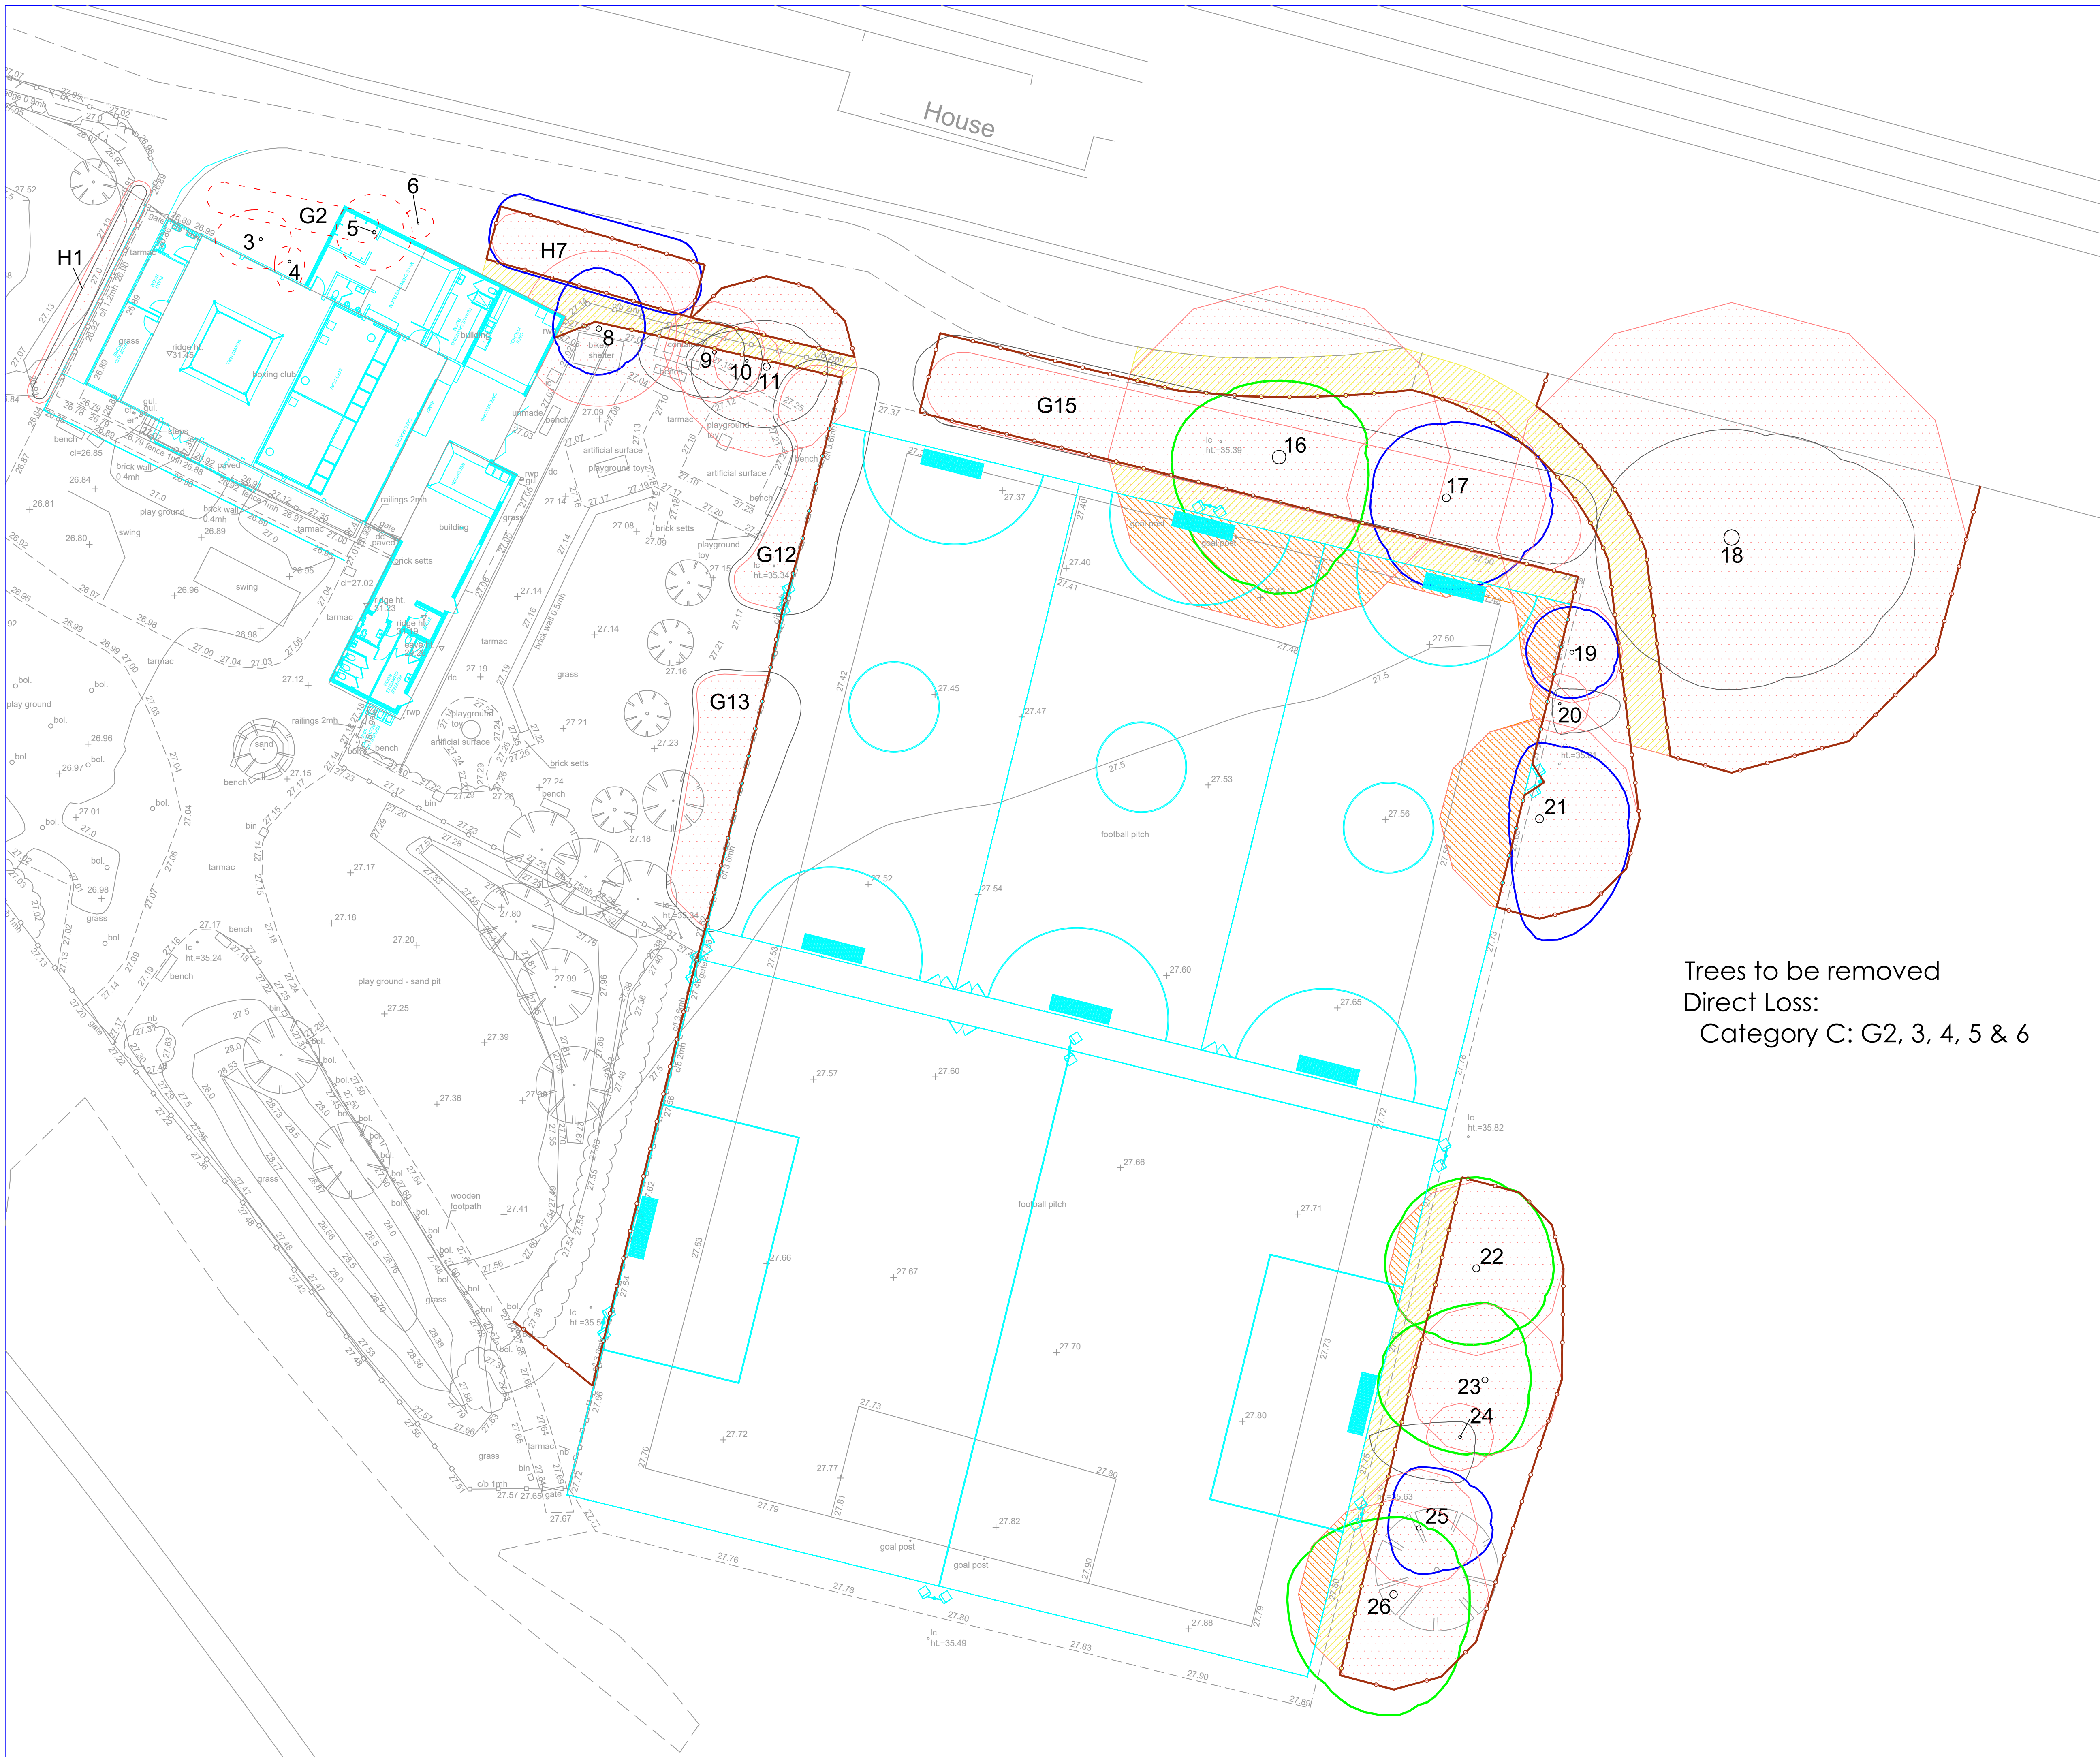
APPENDIX 5

Trees to be removed
 Direct Loss:
 Category C: G2, 3, 4, 5 & 6

- The tree protection barrier (TPB) must be installed prior to any demolition or construction activity as shown on drawing PB/MIT-01/07.08 Rev B and remain in situ for the duration of the scheme.

- This is detailed on PB/MIT-01/07.08 Rev B as “Ground protection; temporary” showing the minimum area.
