The survey involved the visual inspection of the following areas of the building noting structural defects:

Goulden House is a six-storey big block of flats containing 269 flats. The site is enclosed by Shuttleworth Road to the North, Bullen Street to the East, Winder Road to the west and Home Road to the south. (Refer to photo 2.2) The balconies face an inner and an outer green. The building was constructed in the early 70's in phases. It is constructed of a combination of load bearing masonry and reinforced concrete frame with flat roof. The edges of the floor slabs and beams are exposed on all elevations (Refer to Photo 2.1).

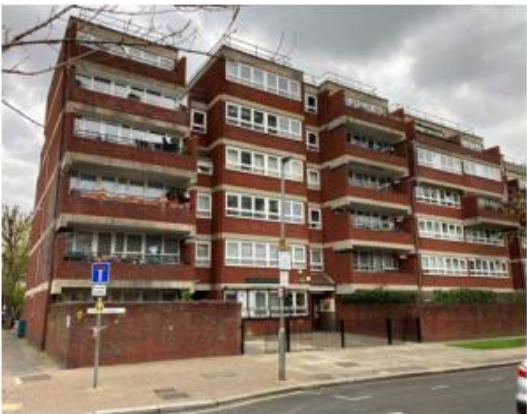
Photo 2.1: Goulden House Elevation on Winder Road

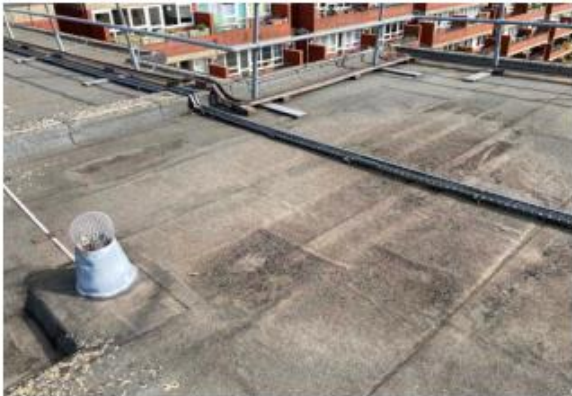
The roof slab is covered with insulation and felt. The drainage inlets are clean and there is evidence of good drainage on the roof. There are however isolated cases of water ponding and a single case where filth is accumulating around the inlet and needs to be cleaned. The reinforced concrete beams on all elevations are experiencing reinforcement corrosion which has resulted in spalling of concrete. The severity ranges from minor to severe. In some cases lumps of concrete have fallen off. The 4th floor walkway is surfaced with asphalt which has uneven surfaces at several locations. Cracks have formed in the asphalt due to the elements. The cracks range from minor to very severe. In some areas the asphalt termination on the wall is peeling off.

Photo 3.1: Roof surface showing evidence of rainwater ponding

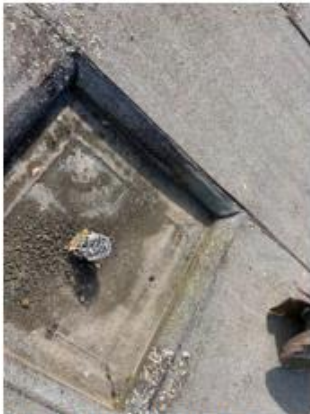
Photo 3.2: Filth around drainage inlet

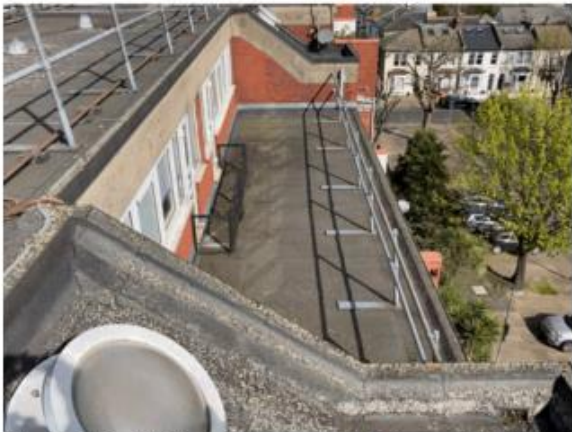
Area	Structural Component/element	Location	Visible defect	Possible causes	Photo Reference in Appendix A
General	Communal terraces	5 th floor adjacent Shuttleworth and Home Road wing junction	Rainwater ponding	Poor drainage of terrace/ blocked drainage inlets	Photo 3.3
	Side walls bordering staircases	4 th floor communal terraces opposite flats 202 218 and 232	Several cracks on side walls	Movement in wall causing cracks in brittle finishes	Photos 3.4, 3.5 and 3.6
	Perimeter beam/slab edge	5 th floor opposite flat 232	Spalling of concrete exposing reinforcement	Reinforcement corrosion	-
	4 th floor sloping roof over staircase to sub entry 247-248	Underneath roof slab within stair well.	Horizontal crack in wall causing water ingress	To be investigated	Photo 3.8
	Perimeter	Elevation	Spalling of concrete	Reinforcement	-

Photo 3.3: 5th floor Communal Balcony Evidence of rainwater ponding

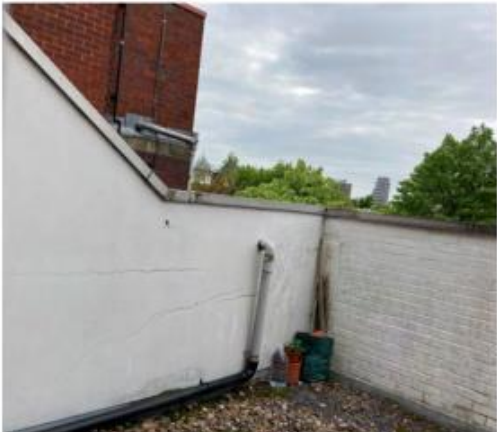
Similar pattern of cracks can be seen where the side walls to the terraces are rendered. The cracks appear to be in the render. Movement of the brick walls could have caused the brittle finishes to crack. Further intrusive investigation will be required to establish the cause of the cracks and undertake repair works. Repair works should be undertaken before the terraces are open to the residents.

Photo 3.4: 4th Floor Communal Terrace opposite flat 202 showing cracking of side wall

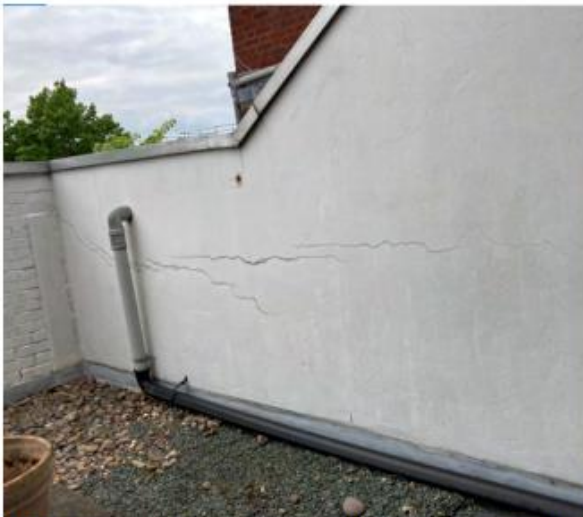
Photo 3.5: 4th Floor Communal Terrace opposite flat 218 showing crack in side wall

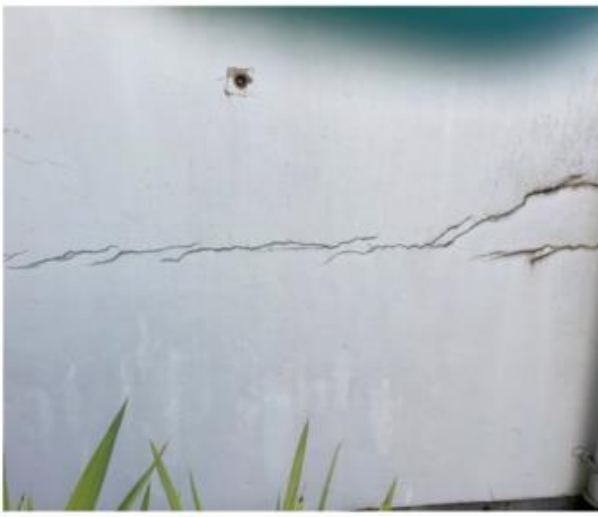
Photo 3.6: 4th Floor Communal Terrace opposite flat 232 showing crack in side wall

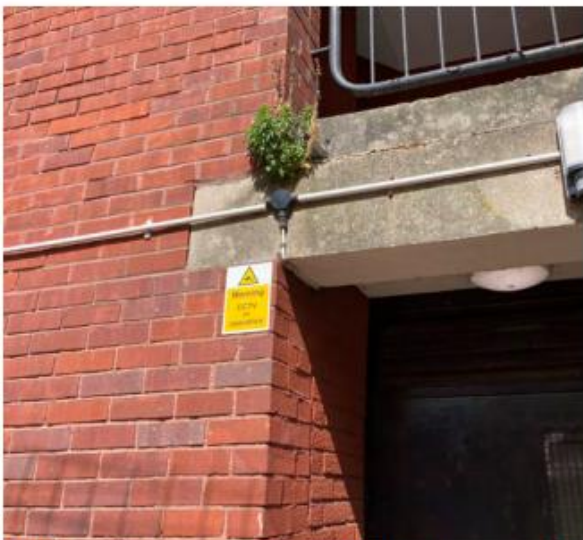
beam/slab edge	adjacent Ball Court at 5 th floor	at corner and side of beam	corrosion	
	Slab edge	5 th floor, top of fire stair well adjacent Ball Court	Vegetation growth	Moisture ingress	Photo 3.7
	Corner of perimeter beam/slab	Floors 1, 2 and 3, Adjacent stairwell adjacent Ball Court	Spalled concrete cover exposing reinforcement	Reinforcement corrosion	-
Roof	Winders Road Wing	Midway	Depressions in roof surface. Evidence of rainwater ponding. Filth around inlet	Uneven roof surface for effective drainage	Photos 3.1 and 3.2
Elevations facing outer green	4 th Floor slab edge/beam	Adjacent sub-entry 109-114	Spalled concrete cover exposing reinforcement	Reinforcement corrosion	-
	3 rd floor slab/beam	Adjacent sub-entry 109-114	Crack at corner	Reinforcement corrosion	-
	4 th floor balcony slab edge	Adjacent sun-entry 115-120	Spalling of concrete cover exposing reinforcement	Reinforcement corrosion	-

Photo 3.7: 5th floor side elevation adjacent Ball Park. Vegetation growth

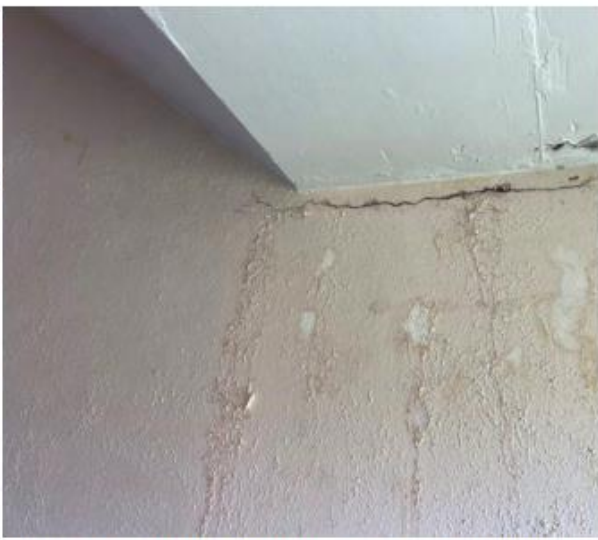
Photo 3.8: Sloped Roof over stairs to sub entry to flats 247-248: Horizontal crack in wall beneath slab. Evidence of moisture ingress.

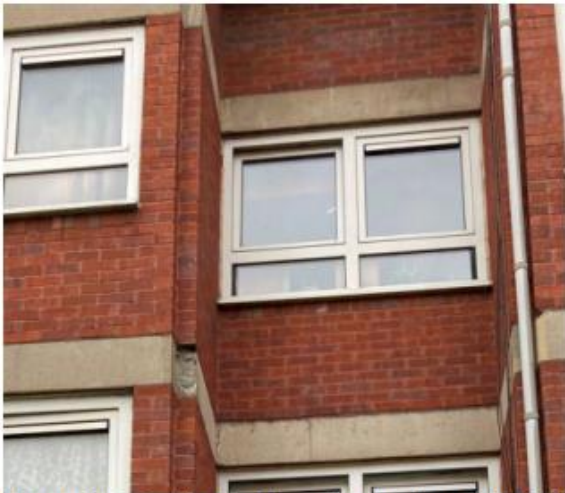
Photo 3.9: 2nd floor slab adjacent flats 128 and 129 Loss of concrete at slab recess leaving brickwork unsupported.

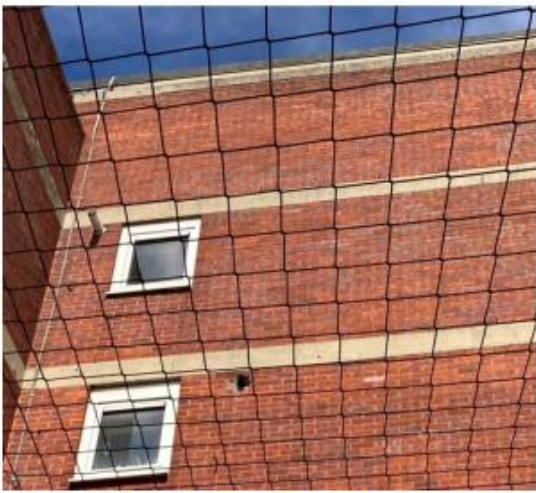
Photo 3.10: Side elevation facing Ball Court showing hole in brickwork underside of 4th floor slab.

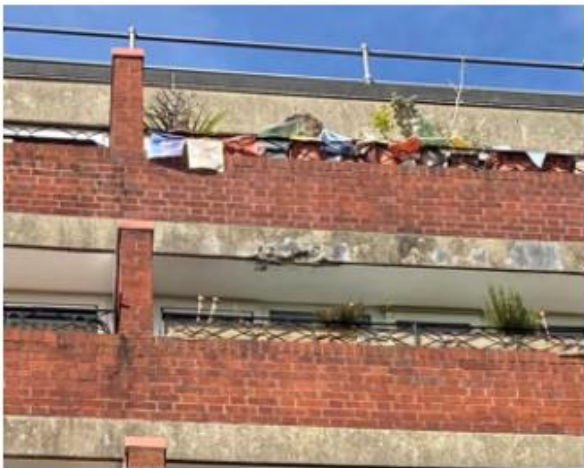
5 th floor balcony and roof slab/beam	Between flats 44 and 38	Spalled concrete exposing reinforcement	Reinforcement corrosion	Photo 3.11
	5 th floor slab/beam	Between sub-entry containing flats 32 and 38	Spalled concrete cover exposing reinforcement	Reinforcement corrosion	-
	5 th floor beam	Adjacent sub-entry to flat 32	Corner of concrete beam cracked.	Reinforcement corrosion	-
	3 rd and 5 th floor slab/beam	Fire stairwell between flat 32 and stairwell	Spalled concrete cover exposing reinforcement	Reinforcement corrosion	-
	2 nd floor slab/beam	Entrance to flats 1 and 2	Cracks in concrete	Reinforcement corrosion	-
	5 th floor slab/beam	Between flats 1/ 2 and 3/4	Spalled concrete adjacent flats 1 and 2 area.	Reinforcement corrosion	-
	3 rd floor slab/beam	Between flats 5 and 6 and fire escape stairwell	Spalled concrete cover exposing reinforcement	Reinforcement corrosion	-
Winders Road	1 st floor balcony cantilever	Adjacent entry to flats 26-28	Cantilever with diagonal crack at the	Reinforcement corrosion	Photo 3.33

Photo 3.11: Spalling of concrete at bottom of 5th floor balcony slab and roof beam facing inner green between sub entry to flats 37-38 and 44-43

Concrete repair works can be undertaken to address the problem. Depending on the degree of spalling the whole surface of local repairs can be undertaken. The process involves testing of the concrete to determine the depth of carbonation and cutting back the concrete to remove all concrete that has been affected. Next the reinforcement is grit blasted to remove all corrosion to the bright metal. The reinforcement is then coated with anti-rust material. Finally, the concrete is repaired using cementitious material such as Fosroc Renderoc products.

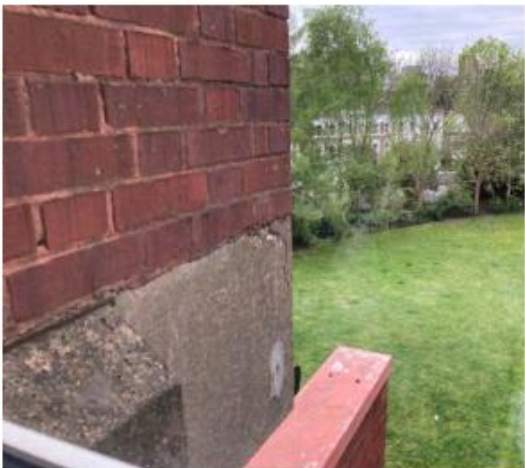
Photo 3.12: Crack in top corner of beam facing green adjacent stairwell to flats 247-248. Visible from landing window.

The cracks in concrete in some of the beams may be due to reinforcement corrosion. Monitoring can also be undertaken to determine whether they are live or historic.

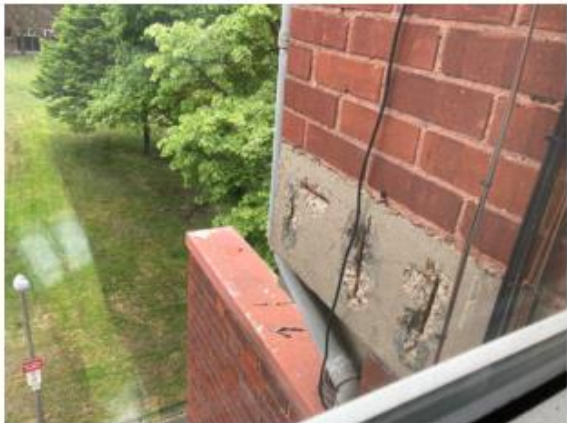
from stair landing window.			
	4 th floor balcony beam	facing green adjacent stairwell to flats 216 and 217. Visible from landing window.	Spalling of concrete on beam surface exposing reinforcement	Reinforcement corrosion	Photo 3.14

Photo 3.14: Spalling of concrete on beam surface exposing reinforcement, facing green adjacent stairwell to flats 216 and 217. Visible from landing window.

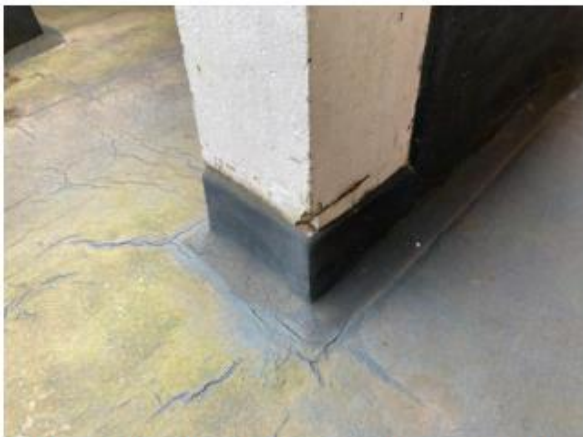
Photo 3.15: Crack in base of column on 4th floor walkway in front of sub entry to flats 252-257

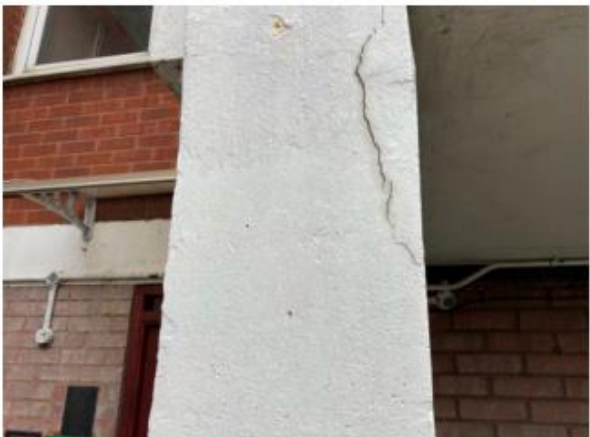
4 th floor column	At RHS of entrance to flats 249-251	Severe crack at base and medium crack at the top.	Reinforcement Corrosion	Photos 3.16 and 3.17
	Masonry top of 5 th floor slab	Between entrance to flats 264-269 and fire escape stairs	Missing bedding to brickwork	Poor workmanship and/or deterioration of mortar	
	4 th floor column	Infront of entrance to flats 252-257	Crack and spalled concrete at base of column	Reinforcement corrosion	Photo 3.15
	4 th floor lintol	Over storage window facing inner green opposite sub entry to flats 227-230	Badly spalled concrete to bottom RHS corner of lintol.	Reinforcement corrosion	Photo 3.38
	4 th floor balcony beam	Facing green adjacent to stairwell to flats 247-248. Visible through stair landing window.	Crack in top corner of beam	Reinforcement corrosion	Photo 3.12
	4 th floor balcony beam	Facing green adjacent stairwell to flats 208-209. Visible	Crack in top corner of beam	Reinforcement corrosion	Photo 3.13

Photo 3.16: Crack at the top of column in front of sub entry to flats 249-251 on 4th floor walkway

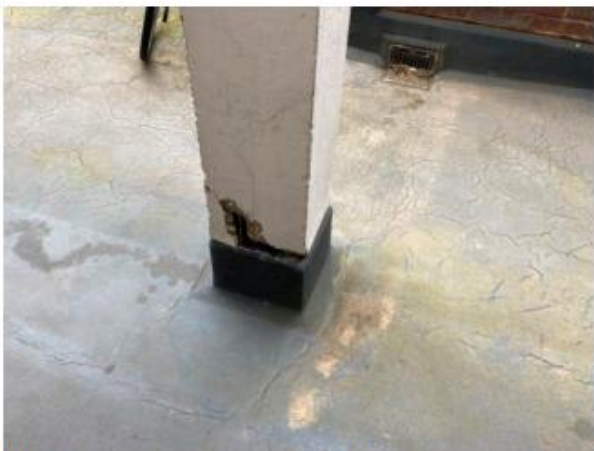
The Column in front of sub entry to flats 249-251(Refer to Photo 3.17 in Appendix A) and the column adjacent to entry to flats 165-170 (Refer to Photo 3.19 in Appendix A) are severely damaged at the base. Urgent attention should be given to repairing these columns before they become dangerous. The lower sections of these columns may need to be rebuilt.

Photo 3.17: Crack and spalling of concrete at base of column in front of sub entry to flats 249-251 on 4th floor walkway.

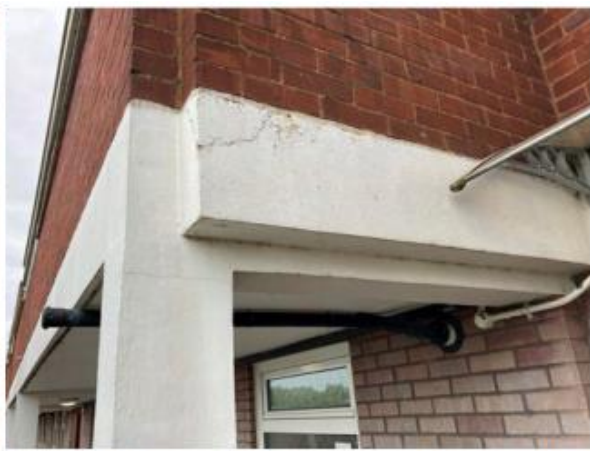
5 th floor beam	RHS entrance to flats 177-182	Spalled concrete at bottom and top corners	Reinforcement corrosion	Photos 3.21 and 3.22
	5 th Floor Beam	Adjacent to entrance to flats 165-170	Diagonal crack in top of beam	Reinforcement corrosion	Photo 3.18
	Column	Adjacent to entrance to flats 165-170	Long crack at base	Reinforcement corrosion	Photo 3.19
	5 th Floor beam and column joint	Adjacent to entrance to flats 171-176	Severe spalling of concrete to beam	Reinforcement corrosion	Photo 3.20
	5 th Floor slab	Between flats 190-194 and 195-197	Concrete spalling from slab edge. Fine crack in slab	Reinforcement corrosion	-
	5 th Floor slab	Adjacent entry canopy to flats 198-200	Spalling of concrete to edge of 5 th floor slab on LHS	Reinforcement corrosion	-
	Corner column	Adjacent entry to flats 198-200	Crack at slab and column joint	Reinforcement corrosion	
	4 th floor column	Adjacent entrance to 264-269	Crack at top of RHS column	Reinforcement corrosion	Photo 3.39

Photo 3.18: crack at top corner of beam LHS of entry to flats 165-170 at on 4th floor walkway.

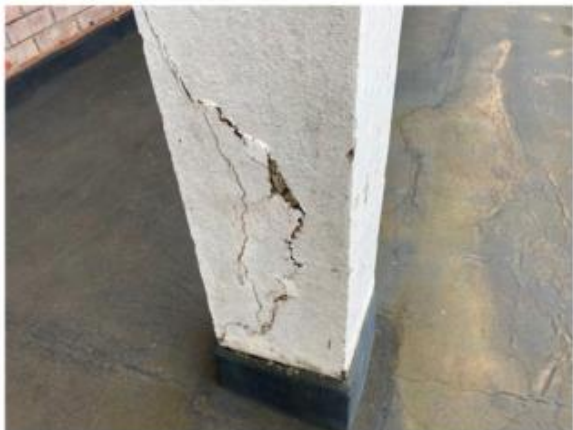
Photo 3.19: Column fractured at bottom on 4th floor walkway, adjacent entry to flats 165-170

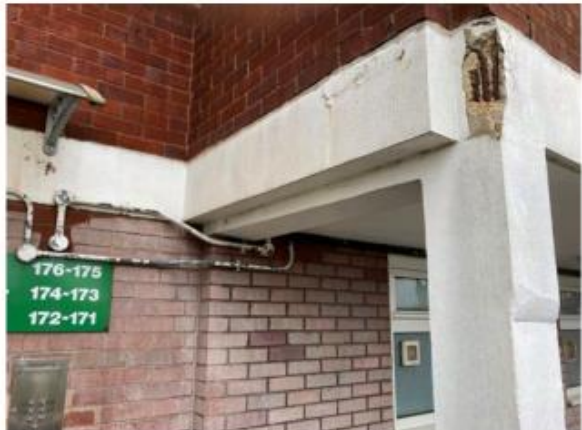
Photo 3.20: Severely spalled concrete exposing reinforcement at beam and column joint on 4th floor walkway adjacent entry to flats 171-176

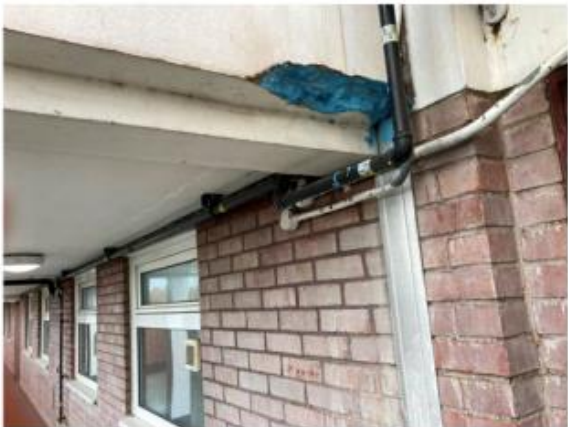
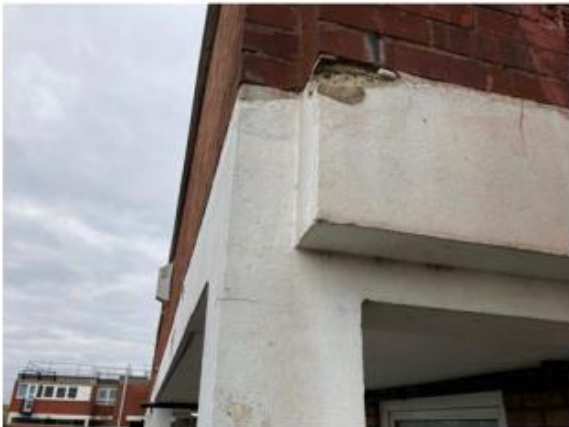
Photo 3.21: Severely spalled concrete with surface painted. Adjacent to entry to flats 177-182 at 4th floor walkway. Same beam in photo 22.

Photo 3.22: Spalling of concrete at top corner of beam. Same beam in photo 21

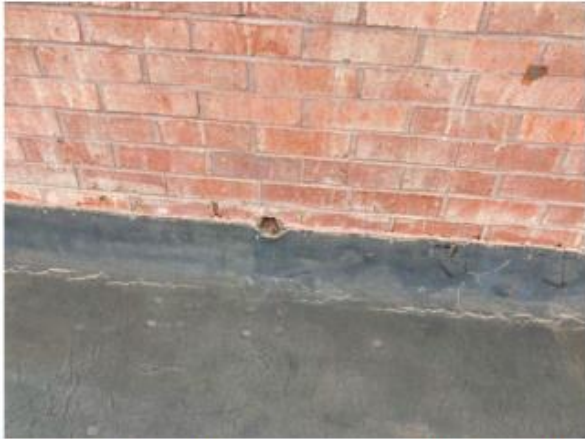
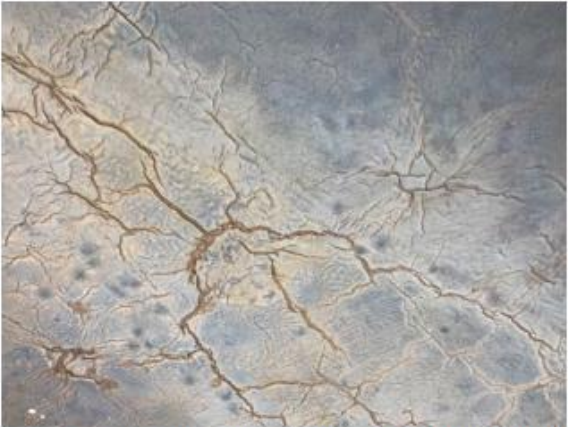
As mentioned in section 3.1, the surface is uneven in many areas. The asphalt has cracks ranging from minor to very severe (Refer to photos 3.24 and 3.25 in Appendix A). The termination on the walls has cracked with holes formed in it and peeling off. The severity of the cracks may have compromised the watertightness which should be investigated.

Photo 3.24: Cracked asphalt termination on wall at 4th floor walkway.

Photo 3.25: Severely cracked asphalt on 4th floor walkway

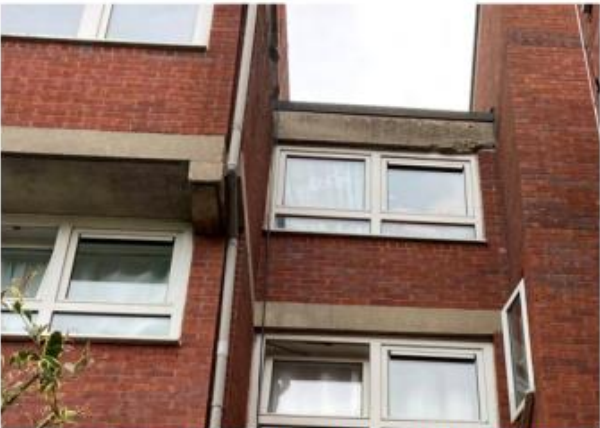
Elevations facing inner green	3rd floor beam /slab edge	Adjacent fire stairwell Block B	Chip at corner	Reinforcement corrosion	-
	First floor perimeter beam/slab edge	facing bike shelter A	Spalled concrete cover exposing reinforcement	Reinforcement corrosion	-
	2nd floor beam/slab	Sub-entry containing flat 121	Loss of concrete at the top on opposite sides	Reinforcement corrosion	-
	4 th floor	Sub-entry containing flat 116	Spalled concrete cover exposing reinforcement	Reinforcement corrosion	-
	4 th floor slab/beam	Sub-entry containing flat 109	Concrete spalling at levels 1, 2, 3 and 4 on both sides at entry point.	Reinforcement corrosion.	-
	2 nd and 3 rd floors beam/slab	Adjacent flat 127, above store shed	Spalled concrete cover exposing reinforcement	Reinforcement corrosion	-
	4 th floor beam/slab	Above flat 127	Severely spalled concrete at bottom left corner of top lintol.	Reinforcement corrosion	Photo 3.26

Photo 3.26: Spalled concrete in bottom corner of top lintol in recessed bay facing inner green above flat 127

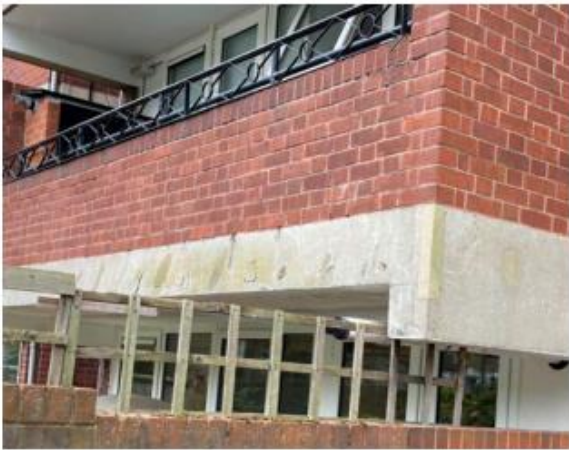
1 st floor slab	Between entrance C and entrance to flat 97	Spalled concrete	Reinforcement corrosion	-
	1 st floor slab	LHS of entrance C	Multiple cracks and bulging in concrete cover	Reinforcement corrosion	Photo 3.27
	4 th and 5 th floors and roof slab	Above entrance to flats 99 and 100	Spalled concrete	Reinforcement corrosion	-
	4 th Floor slab	Between entrances to flats 100-99 and 102-101	Spalled concrete	Reinforcement corrosion	-
	4 th and 5 th floor slab	Recessed bay between Flat 77 and Entrance B	Spalled concrete exposing reinforcement	Reinforcement corrosion	Photo 3.28
Selected Balconies	Flat [REDACTED]	Lintel to living room windows and door	Spalled concrete and drilled holes	Reinforcement corrosion. Drilled holes for fixing ties not reinstated	-
	Flat [REDACTED]	Underside of living room ceiling adjacent balcony lintel	Cracks in paintwork. Damp patch	moisture ingress from roof.	Photo 3.31

Photo 3.27: Multiple cracks on face of concrete slab at 1st floor, LHS of Entrance C on Bullen Street

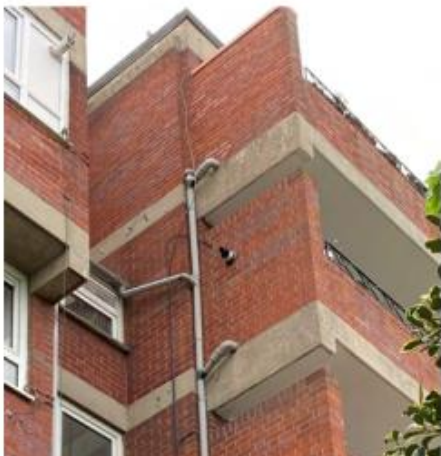
Photo 3.28: Cracks in recessed bay on 4th and 5th floor slab/beam faces adjacent downpipe between Flat 77 and Entrance B on Bullen Street

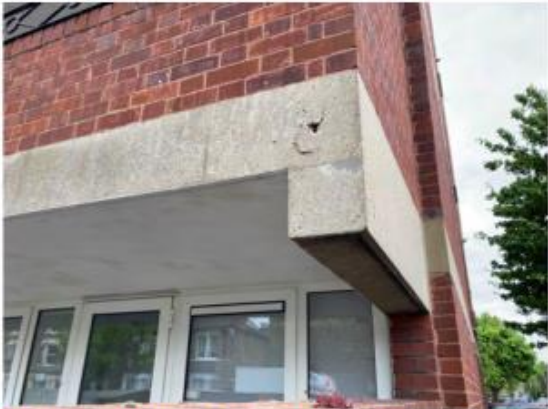
Photo 3.29: Cracked and spalled concrete on face of 1st floor slab at corner of Bullen Street and Shuttleworth Road junction.

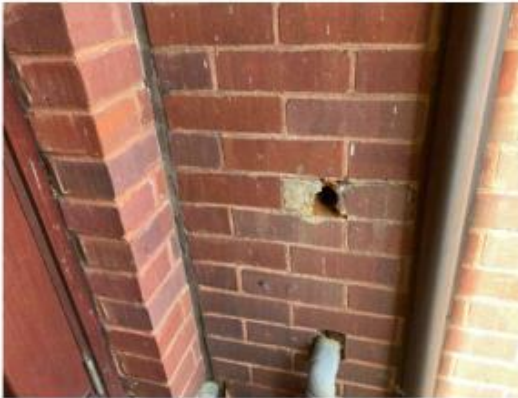
131 & 130			
	3 rd Floor balcony parapet	Between entry to flats 131&130/133 &132	Two flaking bricks	Weathering	-
	2 nd and 3 rd floors	Adjacent ground floor flat 78	Bricks damaged with drilled holes	works undertaken to insert cables.	-
	2 nd floor slab/beam	Adjacent sub-entry containing flat 56	Spalled concrete	Reinforcement corrosion	-
	3 rd floor beam	Adjacent to sub-entry containing flat 56	Spalled concrete at corner of cantilever	Reinforcement corrosion	-
	3 rd floor beam/slab	Between entrances to flats 50 and 56	Spalled concrete	Reinforcement corrosion	
	5 th floor slab/beam	Between entrances to flats 50 and 56	Spalled concrete	Reinforcement corrosion	
	2 nd and 3 rd floor slab	Adjacent sub-entry containing flat 44 near down pipe	Cracks in concrete. Repair works carried out in the past but cracks have reappeared	Reinforcement corrosion	
	Ground floor	Brick wall at entrance to flat 44	Hole in brick work at bottom right.	Created by removal of pipe which was not reinstated	Photo 3.30

Photo 3.30: Entrance side wall to flat [redacted] facing inner green showing hole in brickwork resulting from pipe removal.

Generally, the brick work is in good condition. There are however isolated cases listed in Table 3.1 where defects such as dislodged bricks, flaking bricks, holes created due to drilling and loss of mortar occur. These can be easily repaired.

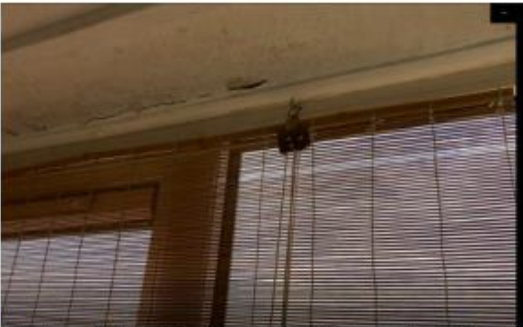
Photo 3.31: Peeling of paint underside of roof slab in living room of flat [redacted]

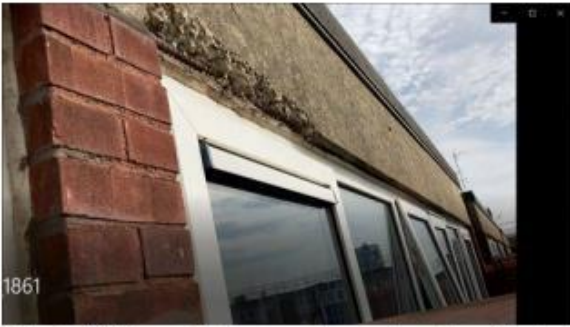
Flat [REDACTED]	Balcony upstand supporting brick parapet	Spalled concrete	Reinforcement corrosion	-
	Flat [REDACTED]	Lintel to living room windows and door	Severely spalled concrete	Reinforcement corrosion	Photo 3.32
	Flat [REDACTED]	Balcony upstand supporting brick parapet.	Spalled concrete	Reinforcement corrosion	-
	Flat [REDACTED]	Lintel to living room	Drilled holes to insert ties not reinstated		-
	Flat [REDACTED]	Lintel to living room	Ties left in place. Spalling of concrete at LHS	Reinforcement corrosion	-
	Flat [REDACTED]	Upstand and lintel	Spalling of concrete	Reinforcement corrosion	-
4th Floor Walkway	Asphalt surfacing to walkway	General	uneven surface and cracks ranging from medium to severe.	Weathering	Photo 3.25
	Asphalt surfacing and termination on walls	Adjacent entry to flats 198-200	Asphalt severely cracked and termination on wall peeling off.	Weathering	Photo 3.24
	5 th floor slab	Between entrance to flats 177-182 and 183-188	Concrete spalling	Reinforcement corrosion	Photo 3.23

Photo 3.32: spalled concrete underside of balcony lintol in flat [redacted]

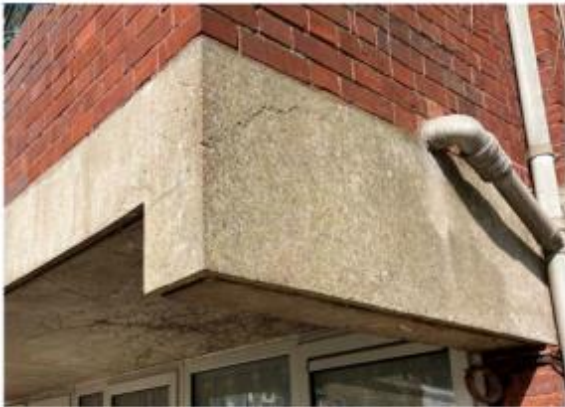
Photo 3.33: crack in repair work to concrete beam in the past

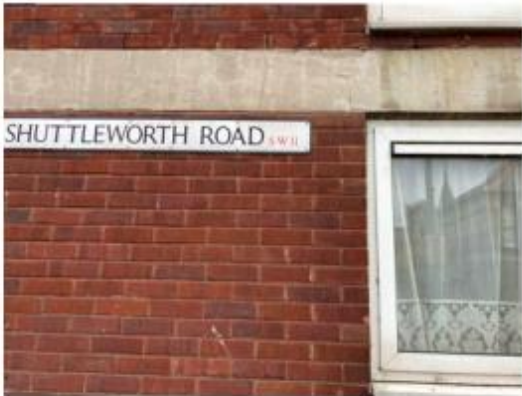
Elevation			top which appears to have been repaired in the past		
	Ground floor lintol	Below entrance A signpost	Spalling of concrete to the side and at the corner.	Reinforcement corrosion	-
	4 th Floor RHS of entrance A	Balcony slab edge/beam between entrance A and flat 24.	Spalling of concrete cover exposing reinforcement	Reinforcement corrosion	-
	4 th floor slab/beam	Above entrance to flats 12-11	Spalled concrete above entrance 12-11	Reinforcement corrosion	-
	4 th floor beam/slab	Above entrance to flats 12-11	Spalled concrete cover exposing reinforcement		-
	2 nd floor beam/slab	Between entrance to flats 8-7 and end of block	Spalled concrete cover exposing reinforcement	Reinforcement corrosion	-
	Transformer room door lintol	Corner of Winders Road and Goulden House approach	missing Brick cladding to lintol missing	Loss of bond between concrete and mortar.	
Shuttleworth Road Elevation	Ground floor beam above "Shuttleworth Road" signage	Adjacent Shuttleworth Road junction with Winders Road.	Fine vertical crack in beam at top of window	Thermal/shrinkage crack	Photo 3.34

Photo 3.34: Fine crack in beam

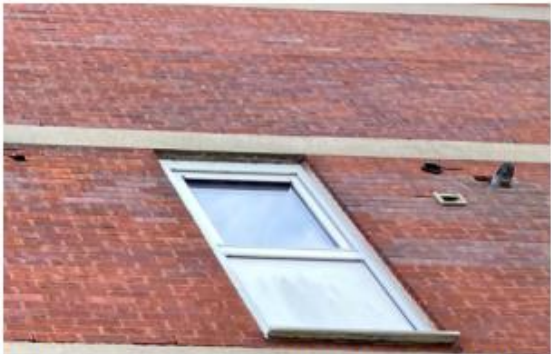
1 ST floor slab/beam	Adjacent entrance to flats 55-60	Crack at corner	Reinforcement corrosion	-
	1 st floor brickwork	Rear of flats 63-65	Loss of pointing	Weathering	-
	3 RD floor brickwork	Flank wall to flats 63-65	Broken and dislodged bricks.	Could be due to removal of ties fixed into the wall.	Photo 3.35
	2 nd floor brickwork	Flank wall to flats 63-65 facing Shuttleworth Road	Location where boiler exhaust pipe is inserted. Bricks dislodged	Damage caused by boiler installers and not reinstated.	Photo 3.36
Bullen Street Elevation	1 st floor slab/beam	Adjacent to entrance to flats 63-65 at corner of Shuttleworth Road and Bullen Street	Spalling of concrete	Reinforcement corrosion.	Photo 3.29
	4 th Floor slab/beam	Between Entrance B and flat 77	Spalling of concrete	Reinforcement Corrosion	-
	5 th Floor Slab Beam	Between Entrance B and flat 77	Spalling of concrete	Reinforcement Corrosion	-
	5 TH Floor	Between entrances B and entrance to Flats 80-79	Vegetation growth on wall	Moisture ingress	-

Photo 3.35: Holes in brick work on Shuttleworth Road elevation to flats 63-65

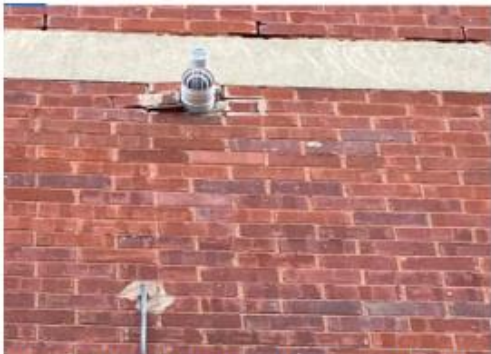
Photo 3.36: Dislodged bricks around boiler exhaust on Shuttleworth Road elevation to flats 63-65

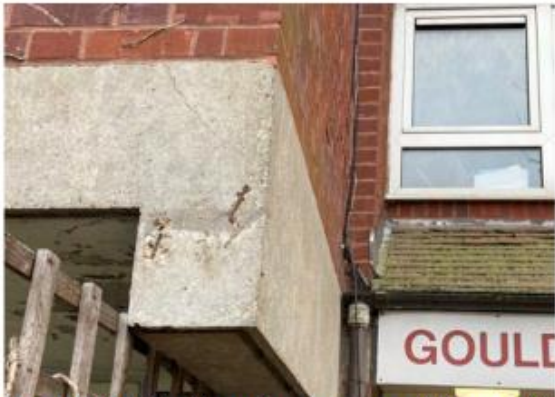
1 st Floor beam/slab	LHS of Entrance B.	Spalling of concrete exposing reinforcement in beam and diagonal crack in slab at corner of slab	Reinforcement corrosion. Diagonal crack requires monitoring and further investigation which is not part of the scope of this survey	Photo 3.37
	1 st Floor slab	LHS of Entrance to flats 80-79 adjacent downpipe	Spalled concrete leaving a hole at slab bottom corner. Evidence of past repair works.	Reinforcement corrosion	-
	5 th Floor Slab	Between Entrance C and entrance to flat 85	Spalled concrete	Reinforcement corrosion	-
	Roof slab edge	Above entrance C	Spalled concrete	Reinforcement corrosion	-

Photo 3.37: Spalling of concrete and diagonal top crack in beam LHS of Entrance B on Bullen Street

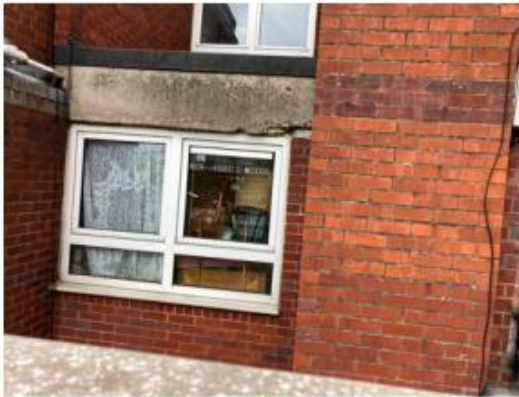
Photo 3.38: Concrete spalling at bottom RHS corner of lintel over storage window

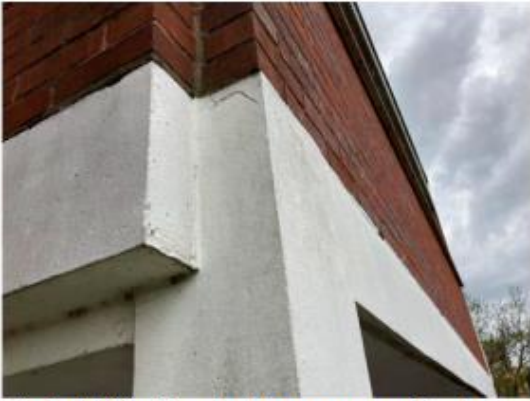
Photo 3.39: Crack at top corner of column on 4th floor walkway adjacent to entrance to flats 264-269
