Mount Clare, Minstead Gardens, Roehampton Gate, London, SW15 4EE

Verification and Critical Analysis Survey Report for
Wandsworth Borough Council
2 December 2025
Our Ref: JP/25-03469

The Lodge / The Bungalow
Mount Clare House
Minstead Gardens
London
SW15 4EE

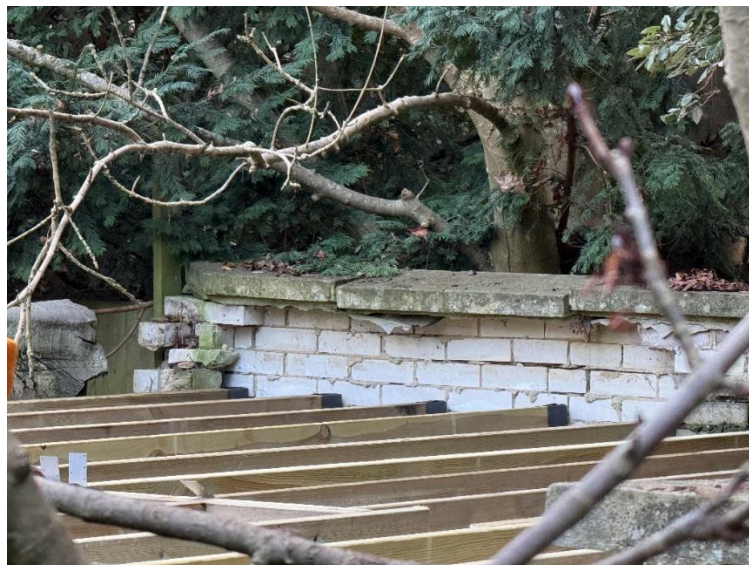
Figure 6: Image taken from our site inspection

- 5.7 This image shows the parapet coping stones to be dislodged along the length of wall and a large gap in the parapet where masonry has collapsed. In our opinion, the walls should not be described as all being intact.
- 5.8 The cause of the walls being in such significant disrepair appears to be caused by the mature trees directly adjacent to the property which have overgrown and literally pushed the masonry walls over. These trees require significant pruning and since the property is within a Conservation Area, this will require a Notification of Proposed Works to Trees in Conservation Areas to be submitted to the Local Authority for assessment.

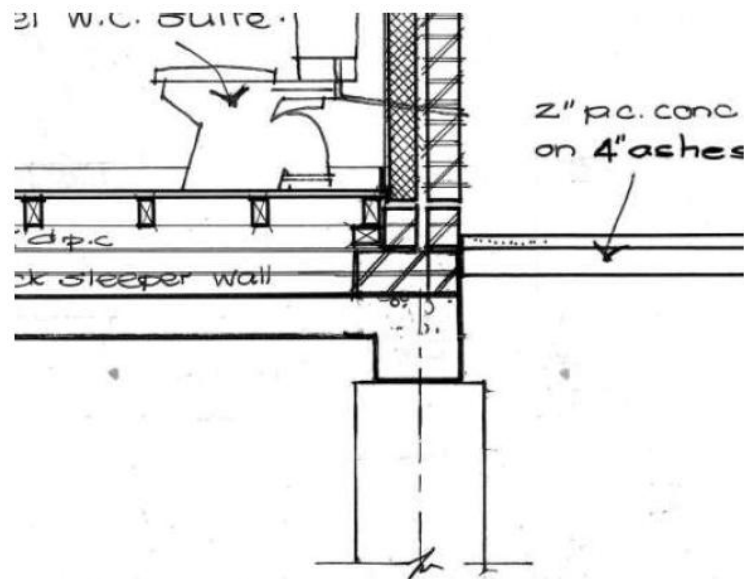
Figure 7: Sectional floor structure detail produced by the original project architect

- 5.10 This does not provide any information regarding the thickness, reinforcement or concrete specification for the ground floor slab or foundations. Whether this can be proven to be in compliance with Part A of the Building Regulations remains to be seen. In order for this to be verified, we would expect to see intrusive investigations to be undertaken with structural calculations carried out which can be provided to Building Control for review.
- 5.11 The following sectional detail shows the construction make-up of the original roof structure:

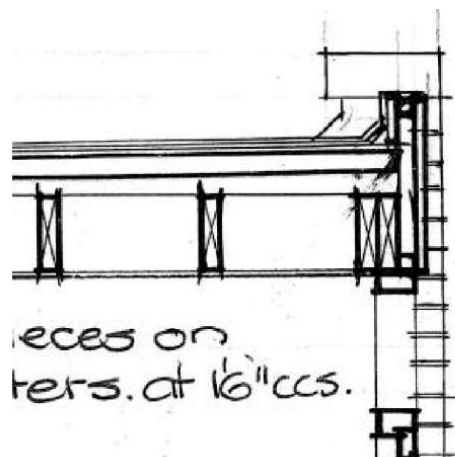
Figure 8: Sectional roof structure detail produced by the original project architect

- 5.12 This shows the low level of the parapet wall detail for the building. The replacement roof which is required will need to meet Part L of the Building Regulations which will lead to an increase in depth of the overall make-up of the roof structure which will require the parapet walls to be raised to accommodate the change in height.

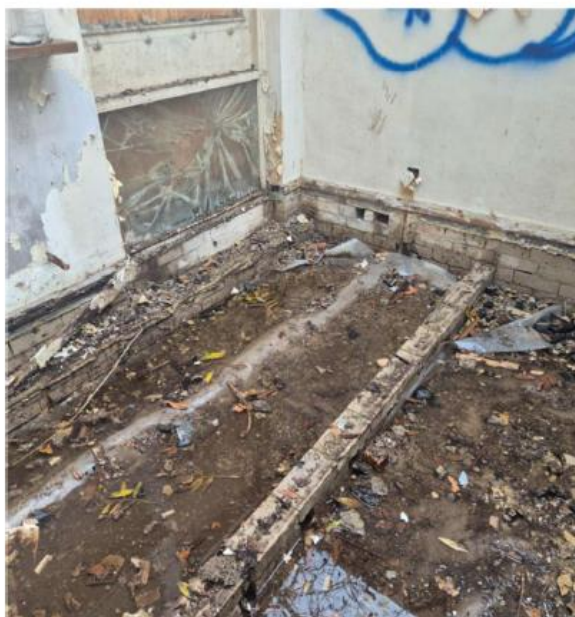
Figure 9: Photograph of the concrete slab below the ground floor joist structure

- 5.14 The report passes comment to state there is a concrete slab below the suspended timber floor, which is no longer in situ, but does not provide any commentary on whether the floor slab is suitable for retention and can be upgraded to meet Building Regulations.
- 5.15 We believe this will require the structure to be verified as suitable with intrusive investigations (Part A), insulation will need to be added (Part L), if a suspended timber floor is to be reinstated, the ventilation provision will need to be checked for suitability (Part C) and the new finished floor level will need to be assessed as to whether the build-up can all be done to provide level, step-free access (Part M).

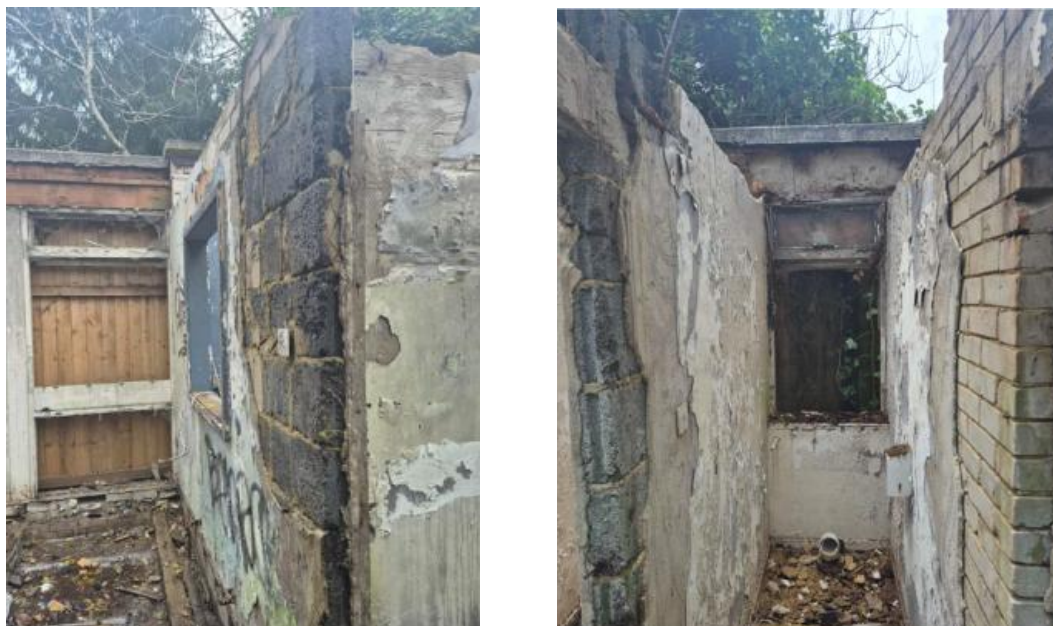
Figure 10: Photographs of an existing window and door to external walls

5.17 This image shows the current arrangement regarding a window and a door to external walls. As can be seen, each aperture has a fan light at the very top which currently extends all the way up to the height of the ceiling to the property. If the depth of the roof joists needs to be thickened or if there was a proposal to insulate from the underside of the joists in any way, the revised ceiling height would interfere with the fan lights. This would mean the design of the windows and doors would need to be altered meaning like for like replacements could not be used.

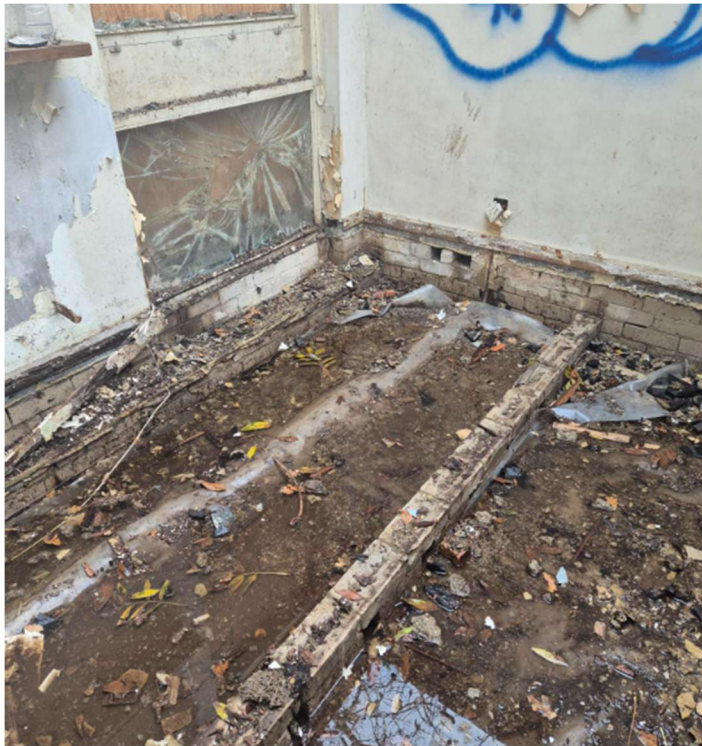
From walking through the property, particularly in areas where the suspended timber floor has been removed, it is obvious that there is a concrete slab below the suspended timber subfloor.

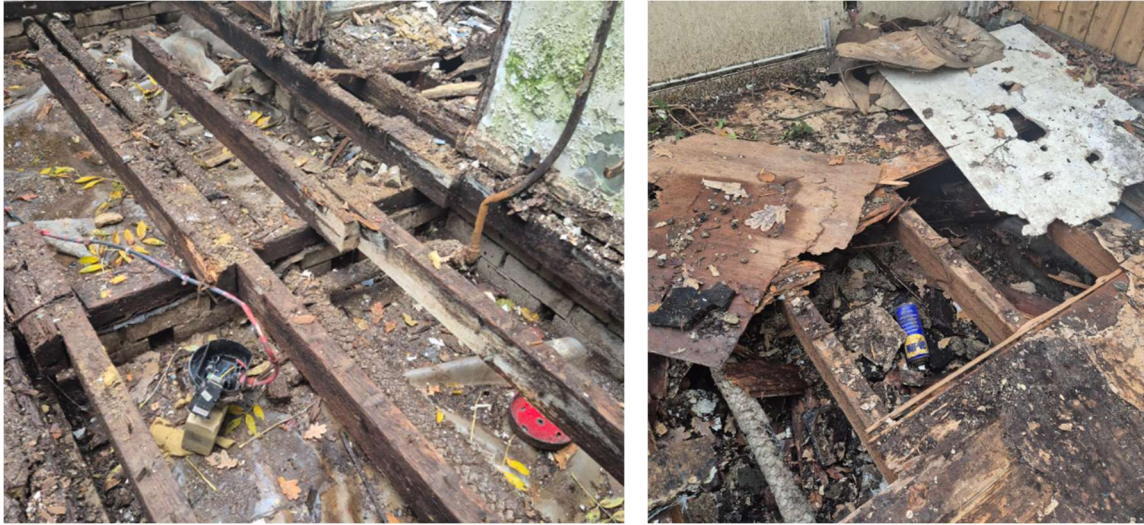
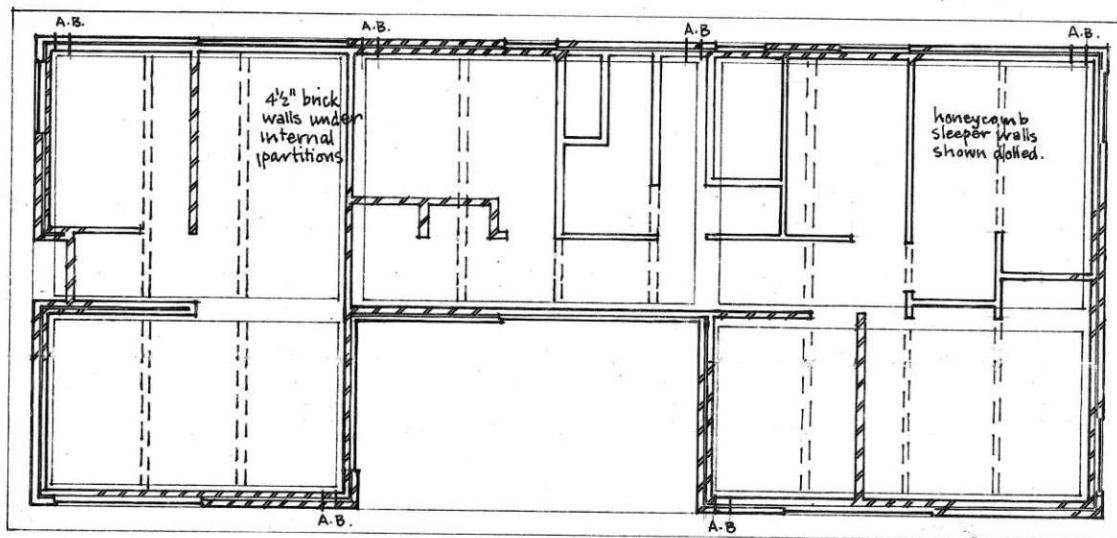
It is evident from the photographs below that the suspended timber floor was supported on sleeper walls, with bricks intentionally omitted within these walls to provide ventilation to the timber structure.

Architectural Layout of Subfloor – which matches what is currently on site.

Joist run from left to right.

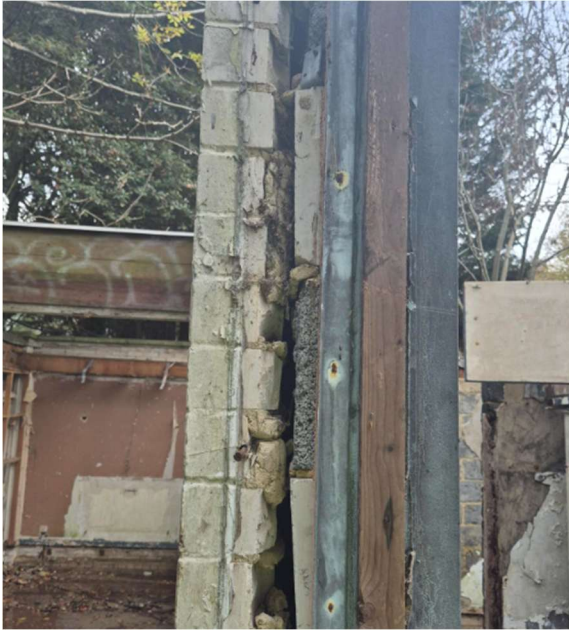
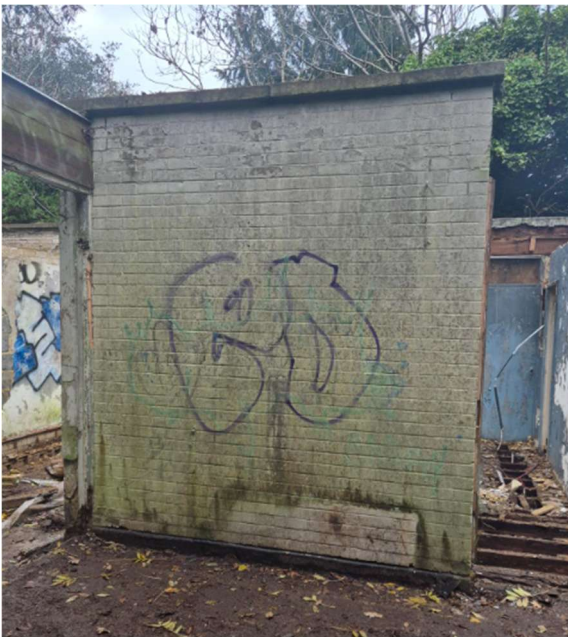
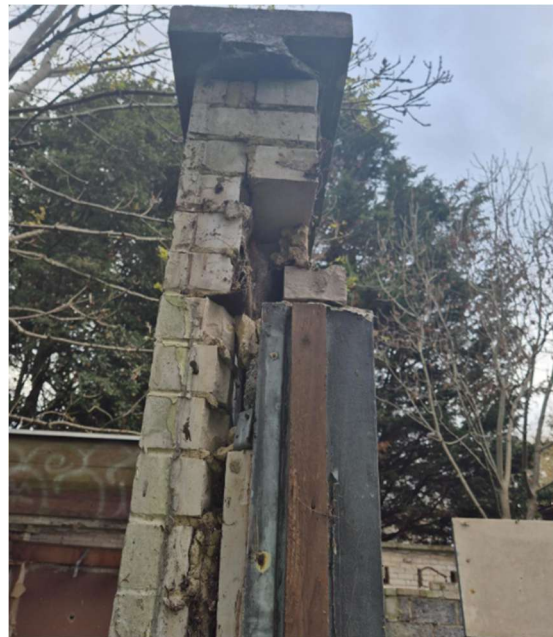
The external cavity wall was inspected on site and the cavity width was found to be approximately 30–50 mm. The internal blockwork leaf typically extends up to the underside of the flat roof joists, above which it transitions to a solid brick parapet surrounding and covering the joists. The masonry elements were observed to be in good condition, as would be expected as these elements would not be impacted by exposure to the elements.

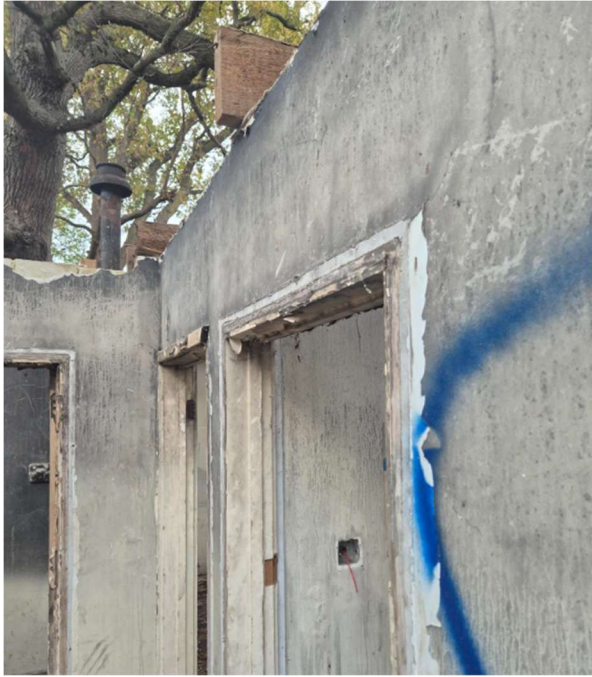
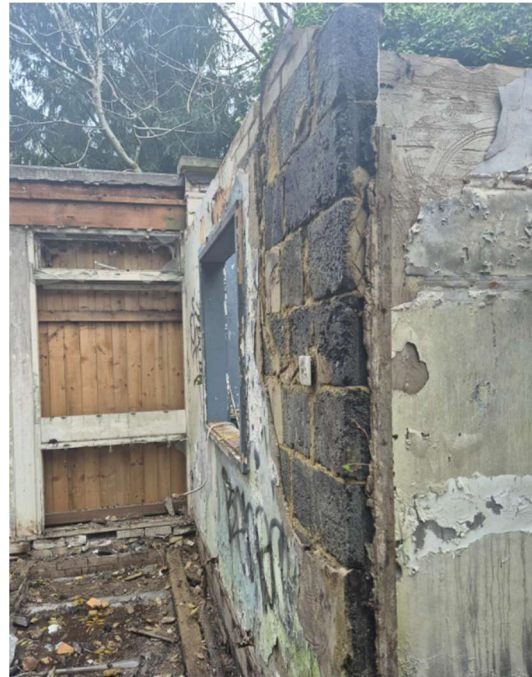
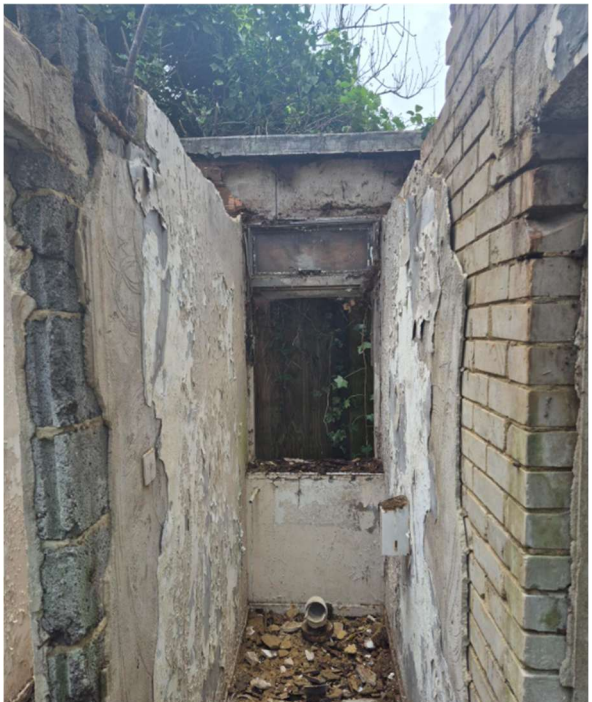
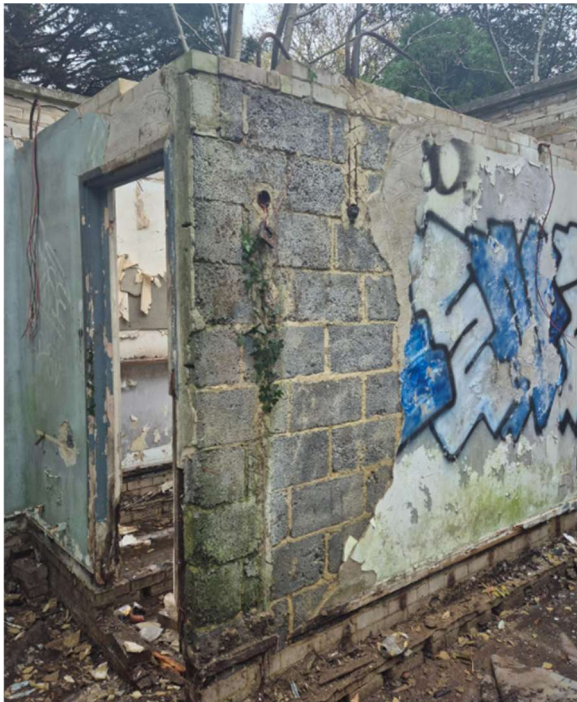
All internal walls on site are a mixture of blockwork and brick. There is a small section of wall which was the old boiler room that is constructed in brick. This is possibly due to the room only having access externally.

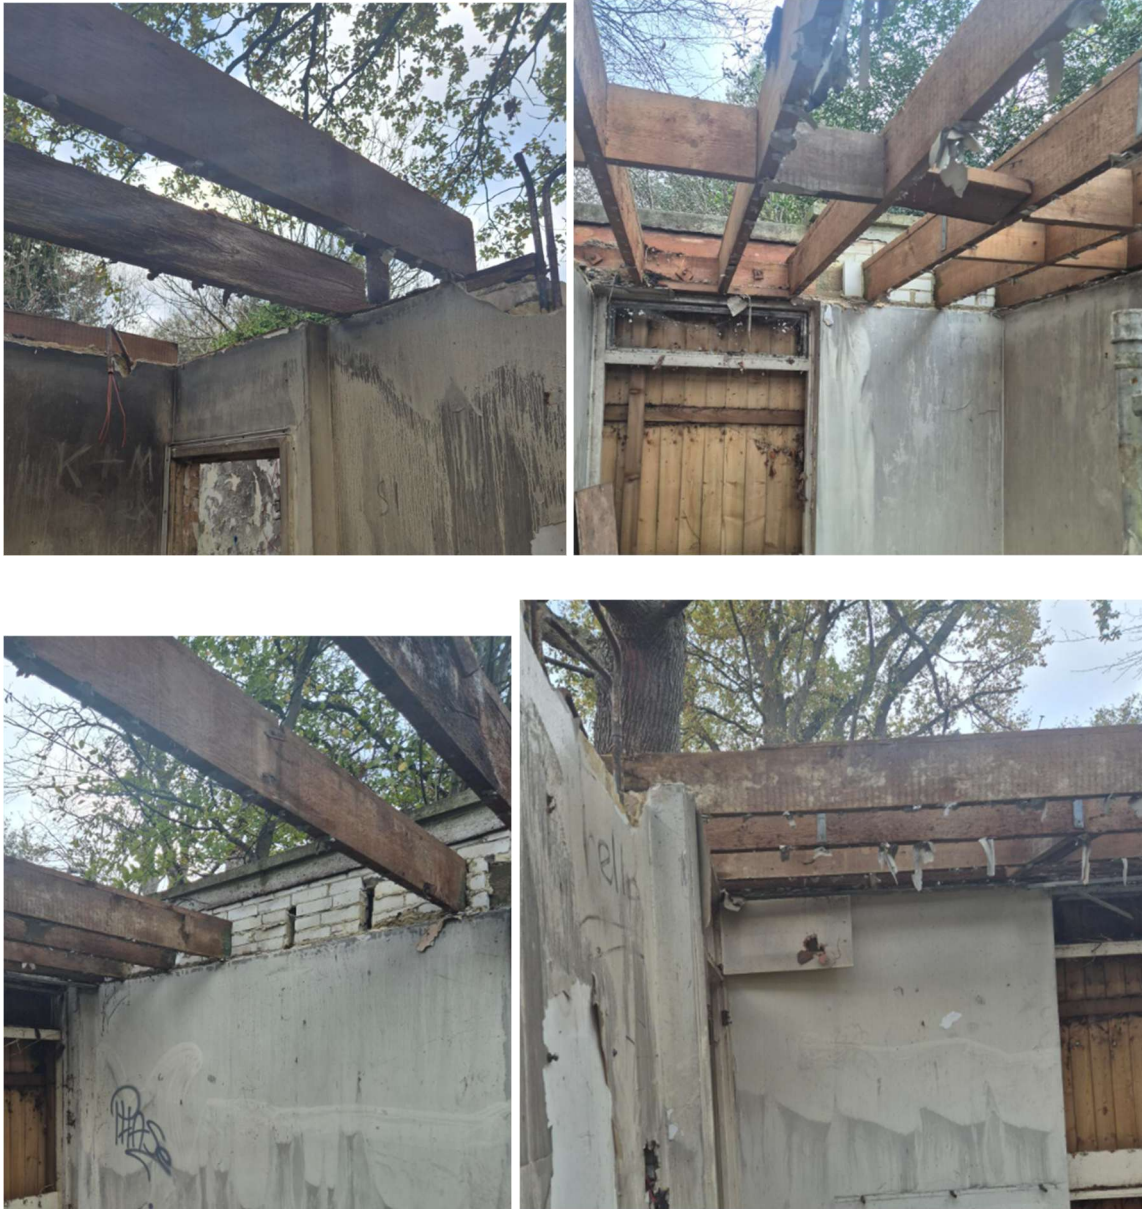
The existing roof structure has been confirmed as comprising 8" × 2" joists at 400 mm centres. Although the majority of the roof has now been removed, several sections remain in place and were inspected. The joists span between the external walls and the internal loadbearing walls, as illustrated in the markup below. The joists are overlapped and supported on the internal walls while at the external cavity walls they are pocketed into the masonry.
