BS 5837:2012 TREE SURVEY AND ARBORICULTURAL METHOD STATEMENT FOR TOOTING TRIANGLE 366 CAVENDISH ROAD LONDON

Prepared on behalf of:
TFC Leisure Ltd
Rocks Lane Multi Sports Centre
Rocks Lane
London
SW13 0DG

Ref: PB/5837-01/07.08

10th September 2019

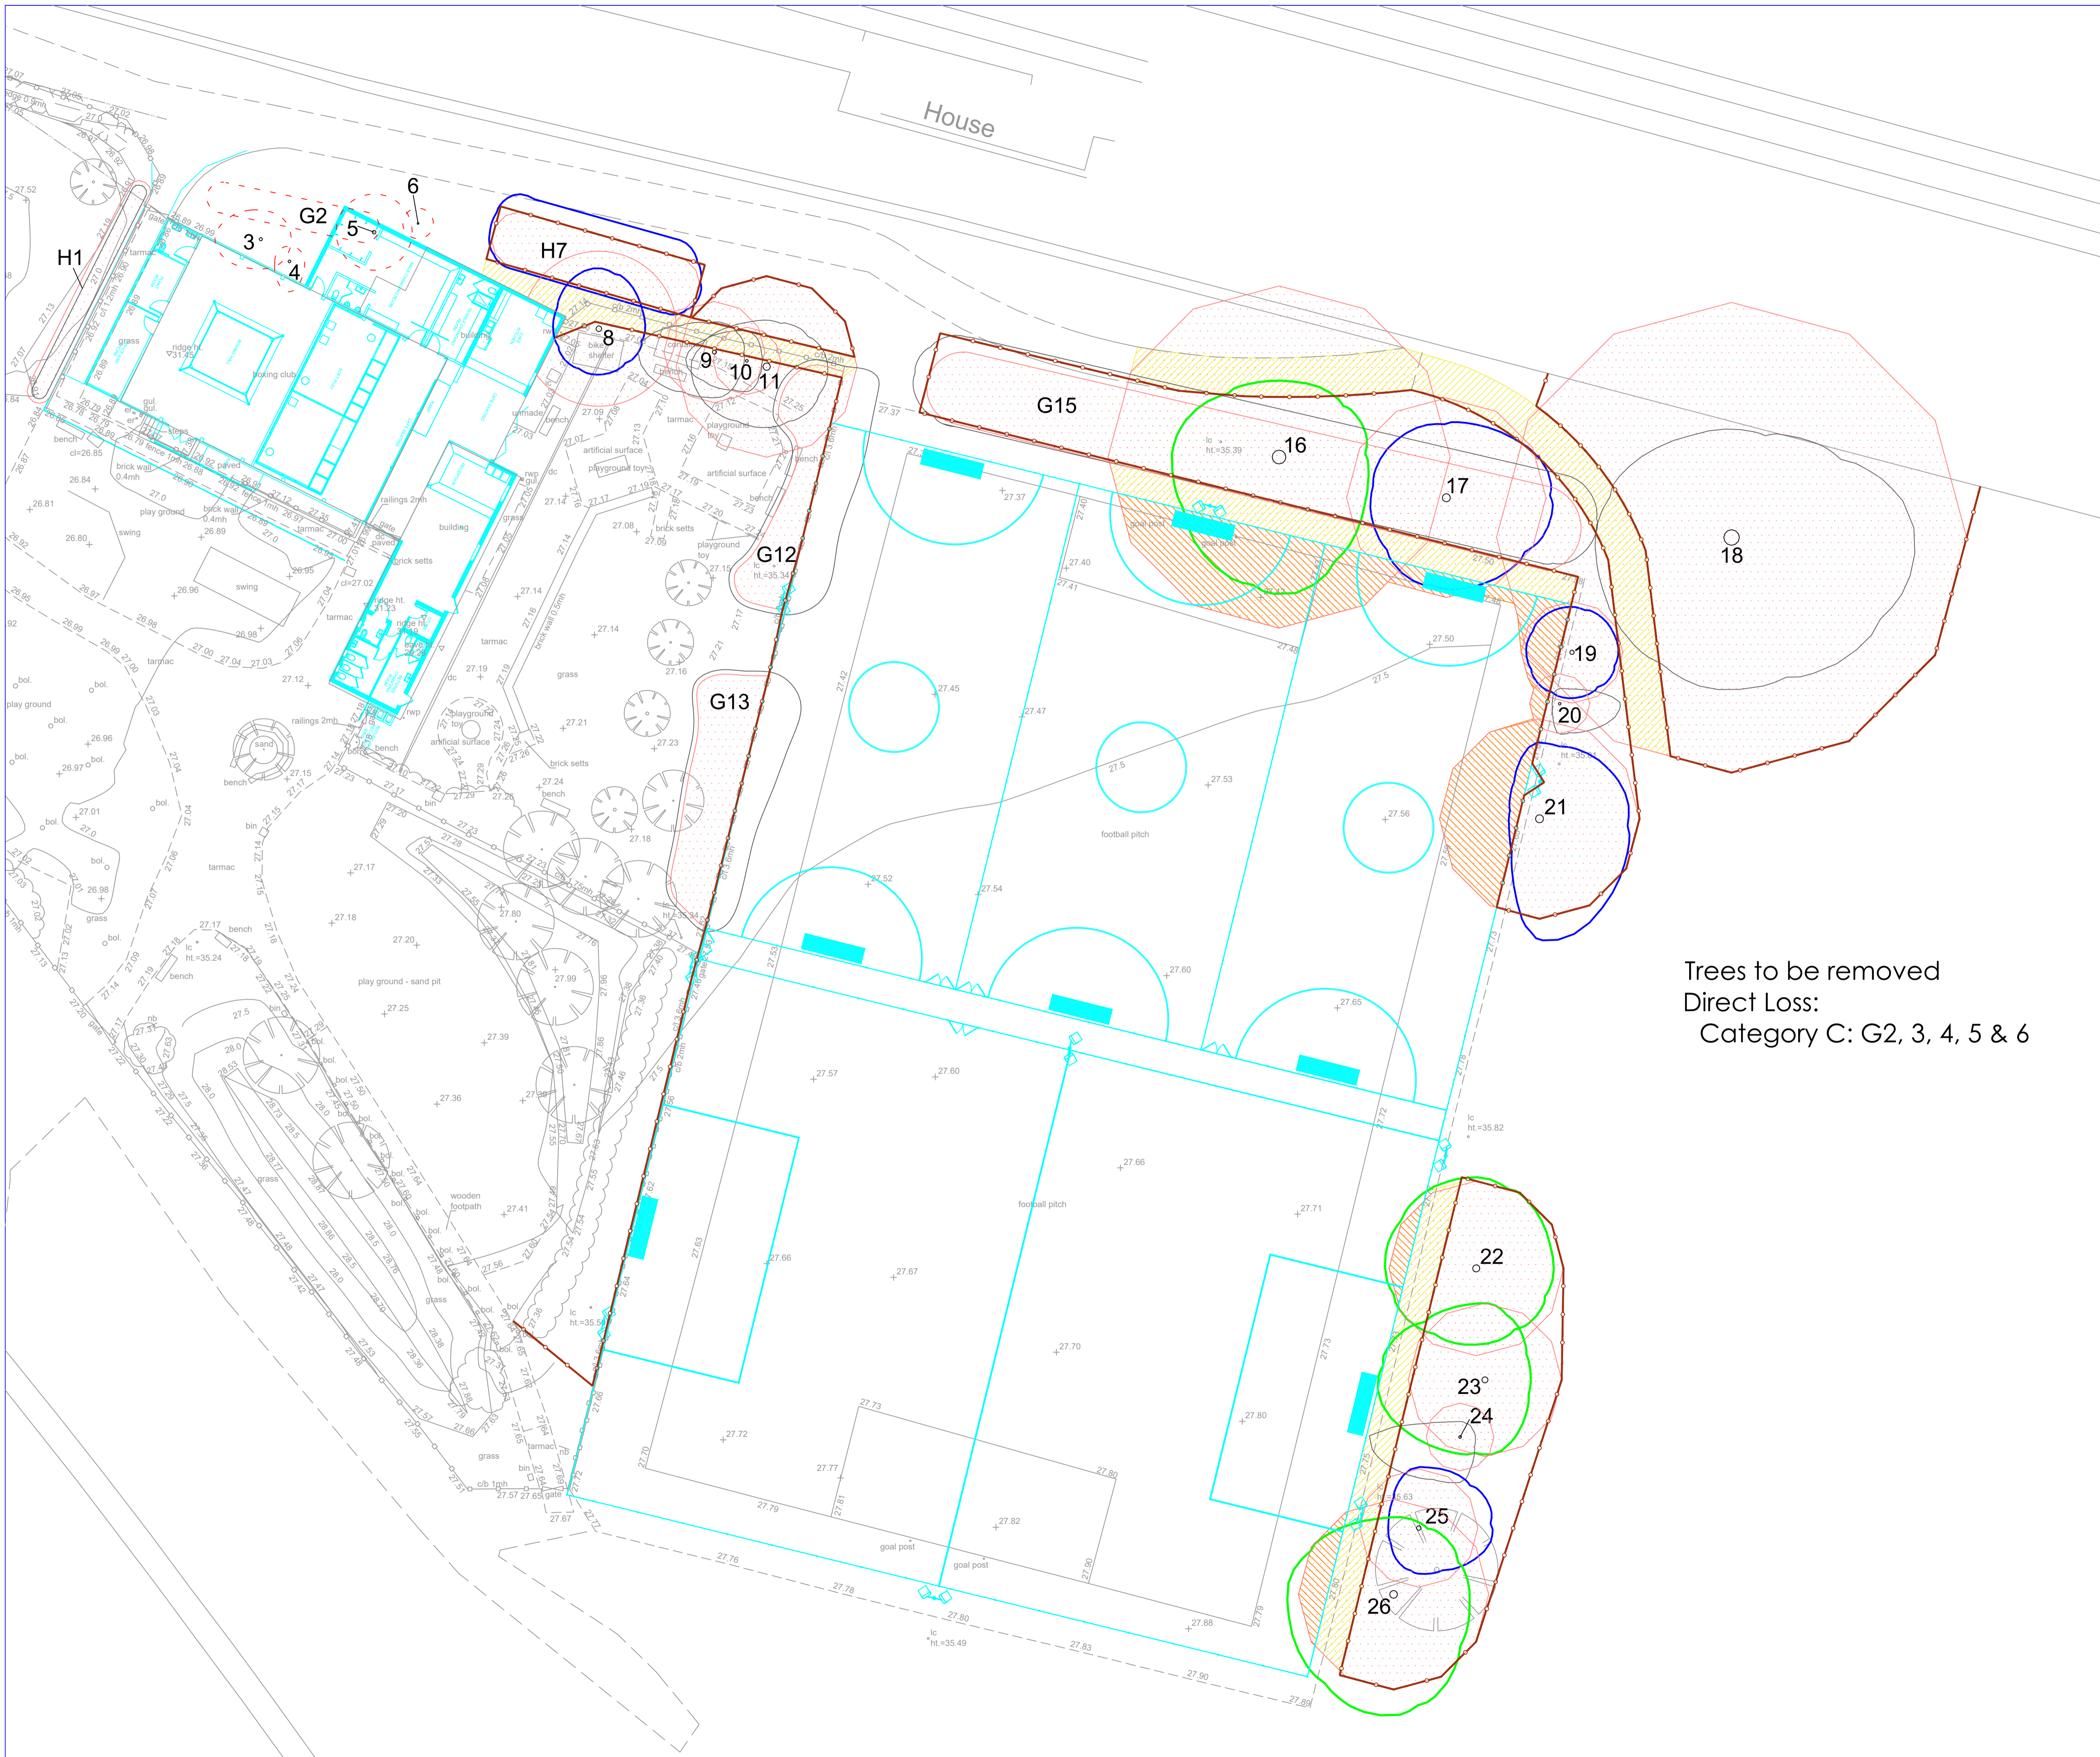
APPENDIX 5

Trees to be removed
 Direct Loss:
 Category C: G2, 3, 4, 5 & 6

- The tree protection barrier (TPB) must be installed prior to any demolition or construction activity as shown on drawing PB/MIT-01/07.08 Rev B and remain in situ for the duration of the scheme.

- This is detailed on PB/MIT-01/07.08 Rev B as “Ground protection; temporary” showing the minimum area.
