BAT HABITAT ASSESSMENT SURVEY REPORT,
BALHAM BOXING CLUB,
CAVENDISH ROAD,
BALHAM, SW12 0PP.

March, 2019

Job Title. Bat habitat assessment report, Balham Boxing Club, SW12 OPP

Purpose Planning application for floodlighting for external use

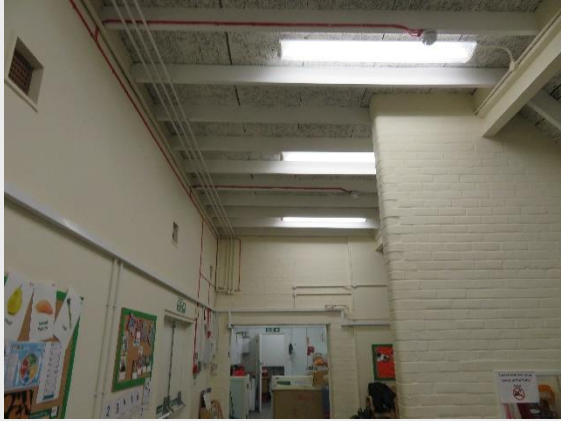
Photograph 1. Underside of roof in the centre

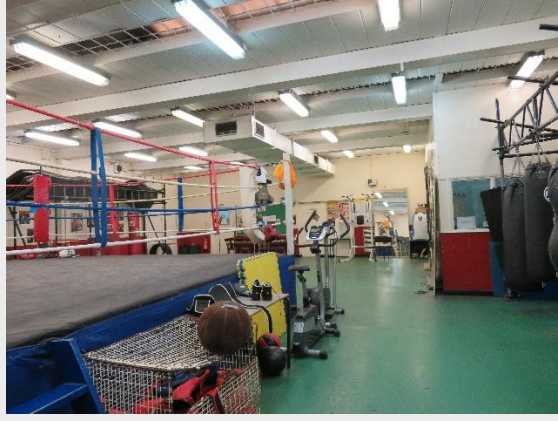
- 3.12 The Boxing ring is in a rectangular metal 'box' with a sophisticated ventilation system with a boiler room and gas flue at the western end. It is extremely well lit and has small storage rooms and office space that were entered.

Photograph 2. Boxing ring

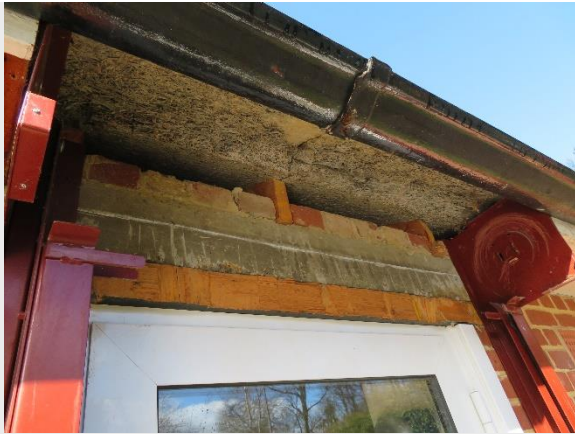
3.6 Above the door into the garden there was damage to metal security shuttering which exposed the eaves into the roof. A gap above the door lintel was also apparent and immediately adjacent was

Photograph 3. Missing metal canopy with gap at eaves above door

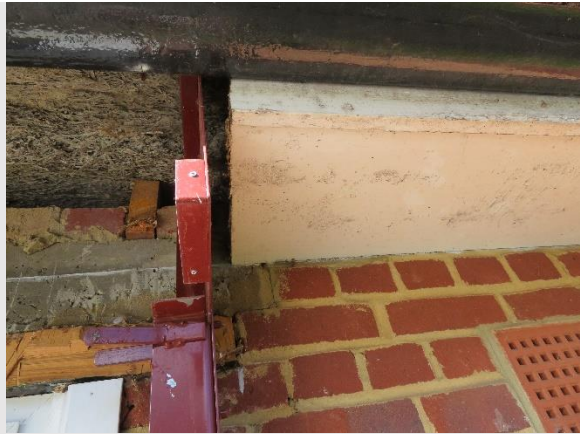
a gap in the soffit formerly used to accommodate the metal shutter. This was the only gap in the soffit and the building was determined as of low potential for bat interest.

Photograph 4. Gap at soffit (area adjacent to photo 3)
