Mount Clare, Minstead Gardens, Roehampton Gate, London, SW15 4EE

Verification and Critical Analysis Survey Report for
Wandsworth Borough Council
2 December 2025
Our Ref: JP/25-03469

The Lodge / The Bungalow
Mount Clare House
Minstead Gardens
London
SW15 4EE

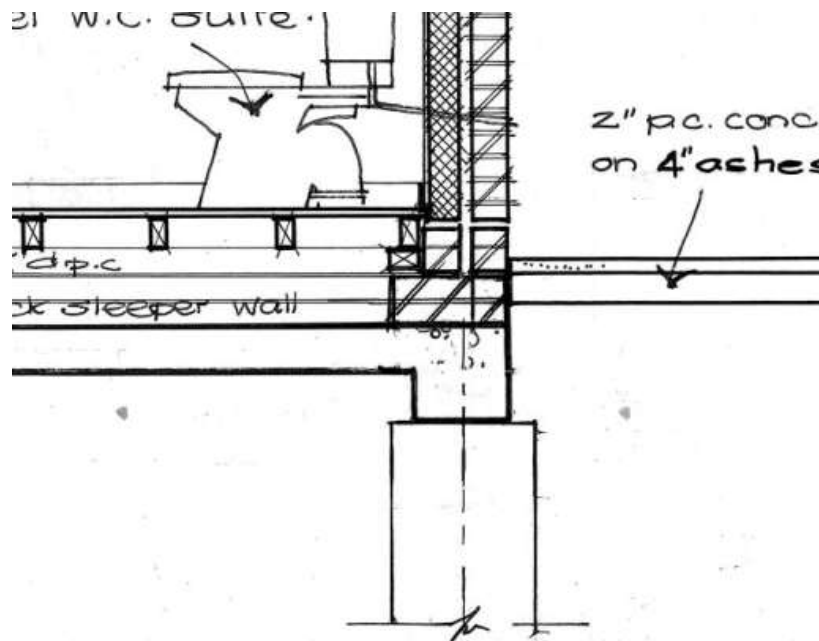
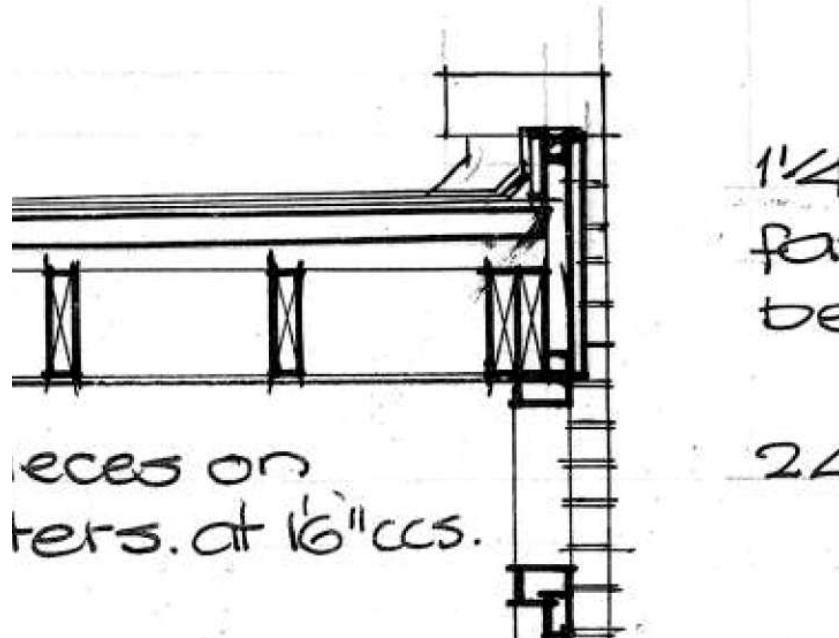
1. Internal walls in the property are blockwork and provide support to the roof structure.
2. The roof comprises of flat roof rafters (8 x 2) which span from the external loadbearing blockwork walls to internal loadbearing blockwork walls.
3. The roof falls centrally to an internal box gutter.

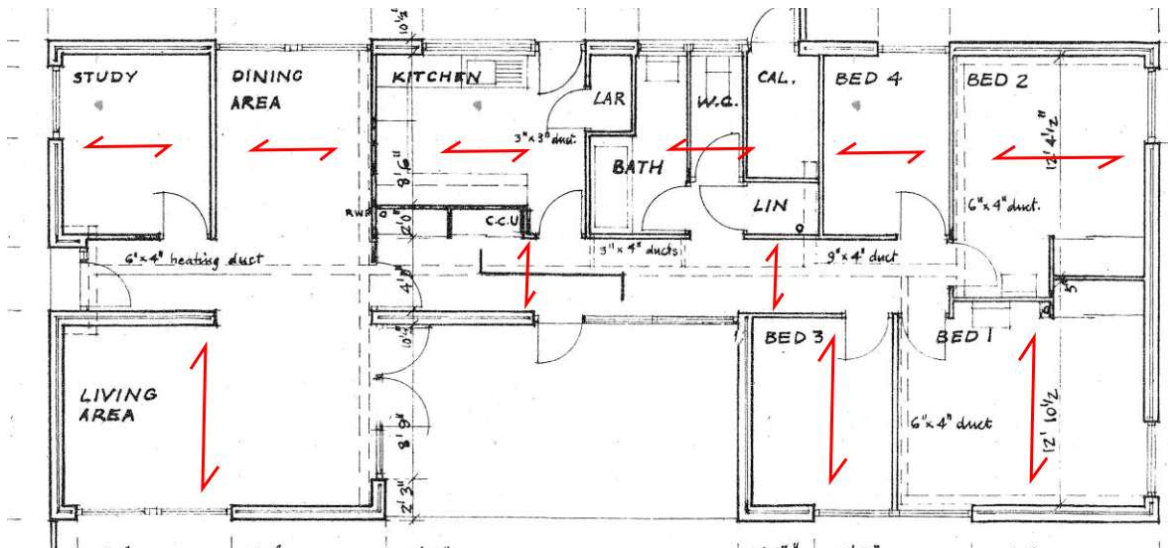
Span of Roof Joists

The existing roof structure has been confirmed as comprising 8" × 2" joists at 400 mm centres. Although the majority of the roof has now been removed, several sections remain in place and were inspected. The joists span between the external walls and the internal loadbearing walls, as illustrated in the markup below. The joists are overlapped and supported on the internal walls while at the external cavity walls they are pocketed into the masonry.
