BOOKERS, 41-49 BATTERSEA PARK ROAD, LONDON

BREEAM UK NEW CONSTRUCTION 2018 WST 01 PRE-DEMOLITION AUDIT REPORT

WATKIN JONES GROUP

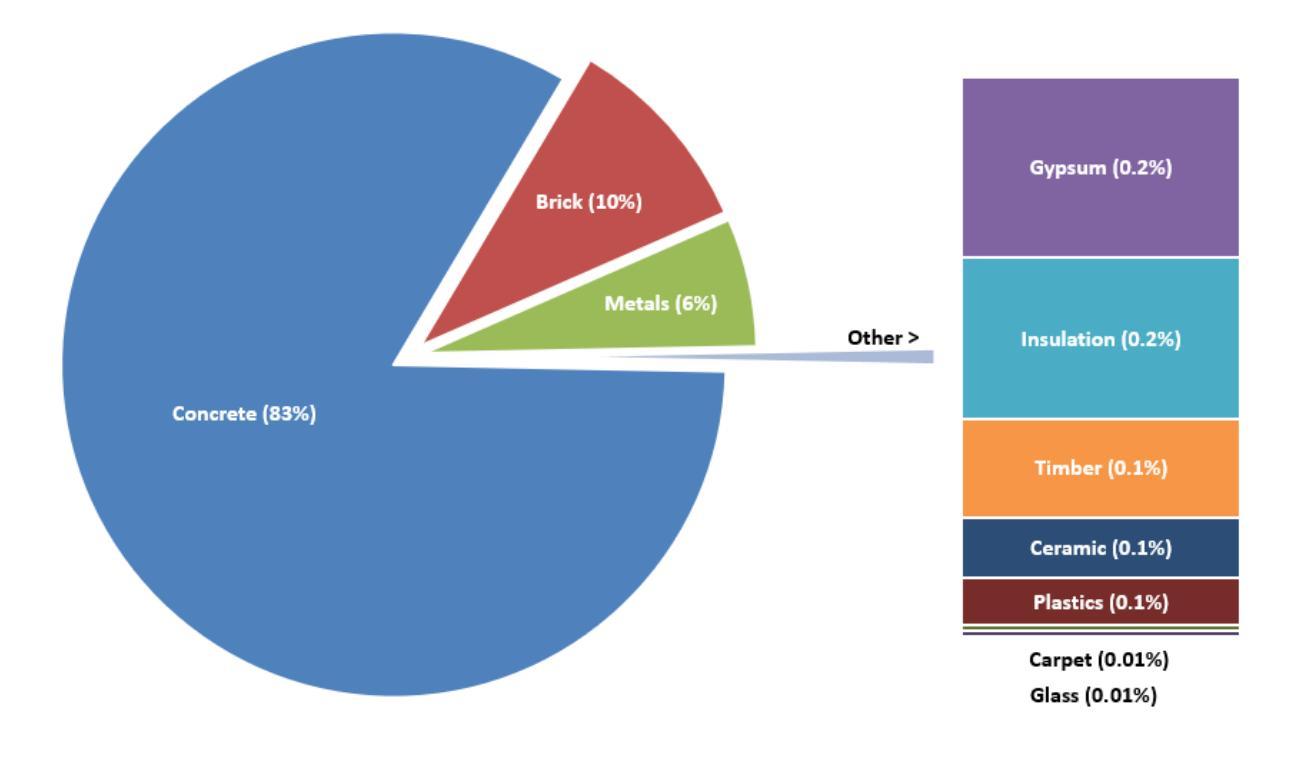
Key Demolition Products (KDP) by percentage weight

The estimated Key Demolition Products (KDP) by weight are Concrete (83%), Brick (10%), Metals (6%), Gypsum (0.2%), and Insulation (0.2%), with smaller amounts of Timber, Ceramic, Plastics and Carpet. Miscellaneous items and WEEE are also present although these have not all been quantified.

It is recommended that a target of 95% diversion of waste from landfill (by weight) should be set. This is mostly through recycling. There may be some opportunity for reuse of some of the steel sections and sheets.

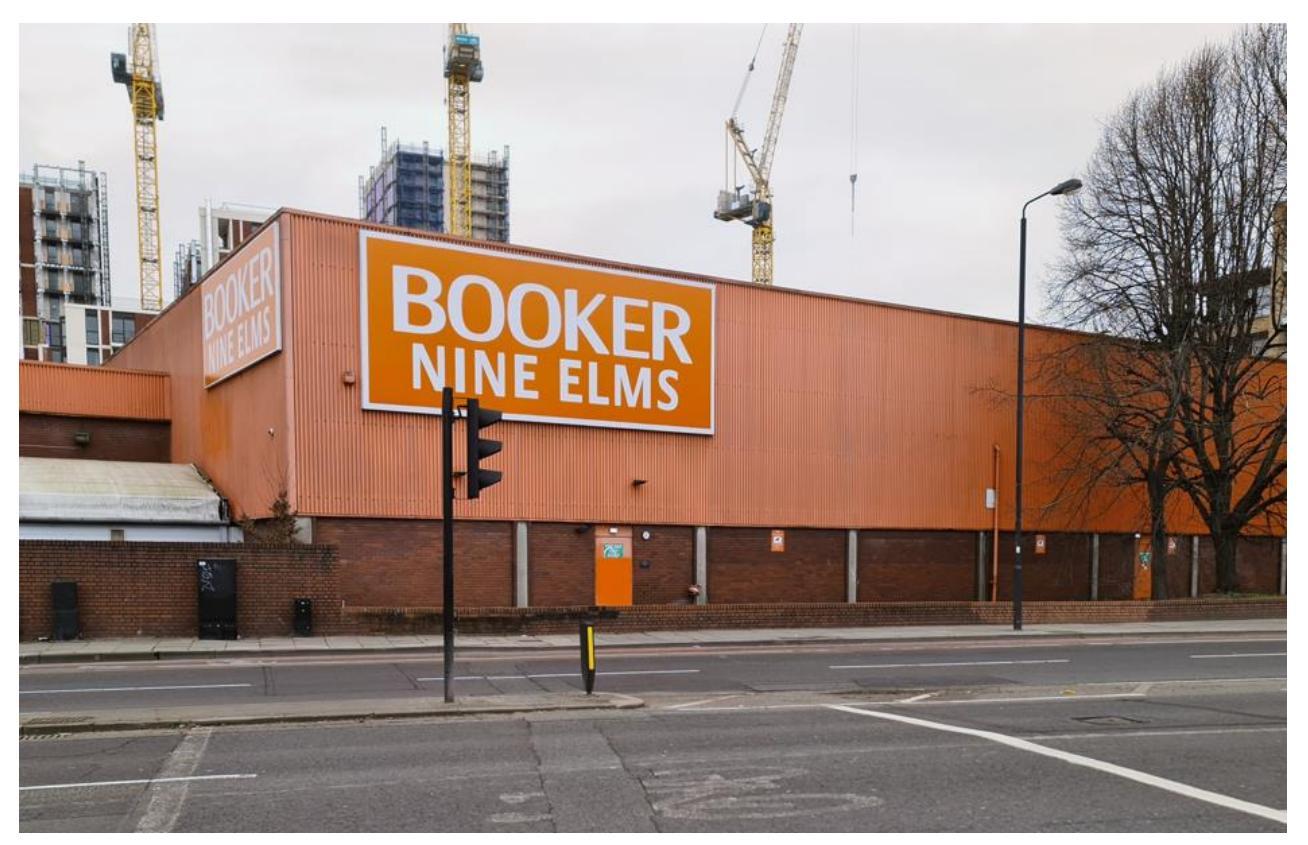
Our understanding is that the existing building on site will be completely demolished; the building is pictured below.

The building is not suitable for reuse and or retrofit. These are for the following reasons:

- The existing building is a brick and block warehouse with a metal roof. The proposed development is
 for entirely different uses (i.e. residential, student accommodation and commercial business use).
 There is therefore no option of refurbishment as it is complete change of use and technically is not
 suited to the new uses of the site.
- The existing warehouse cannot be repurposed to suit the proposed use classes of the new development. The existing building (warehouse) would not be technically fit for purpose or as a habitable space, even through repurposing for the new uses.
- It is unlikely structurally, the building could be adapted i.e. Vertically; more over due to its position on site it is difficult to also extend horizontally.

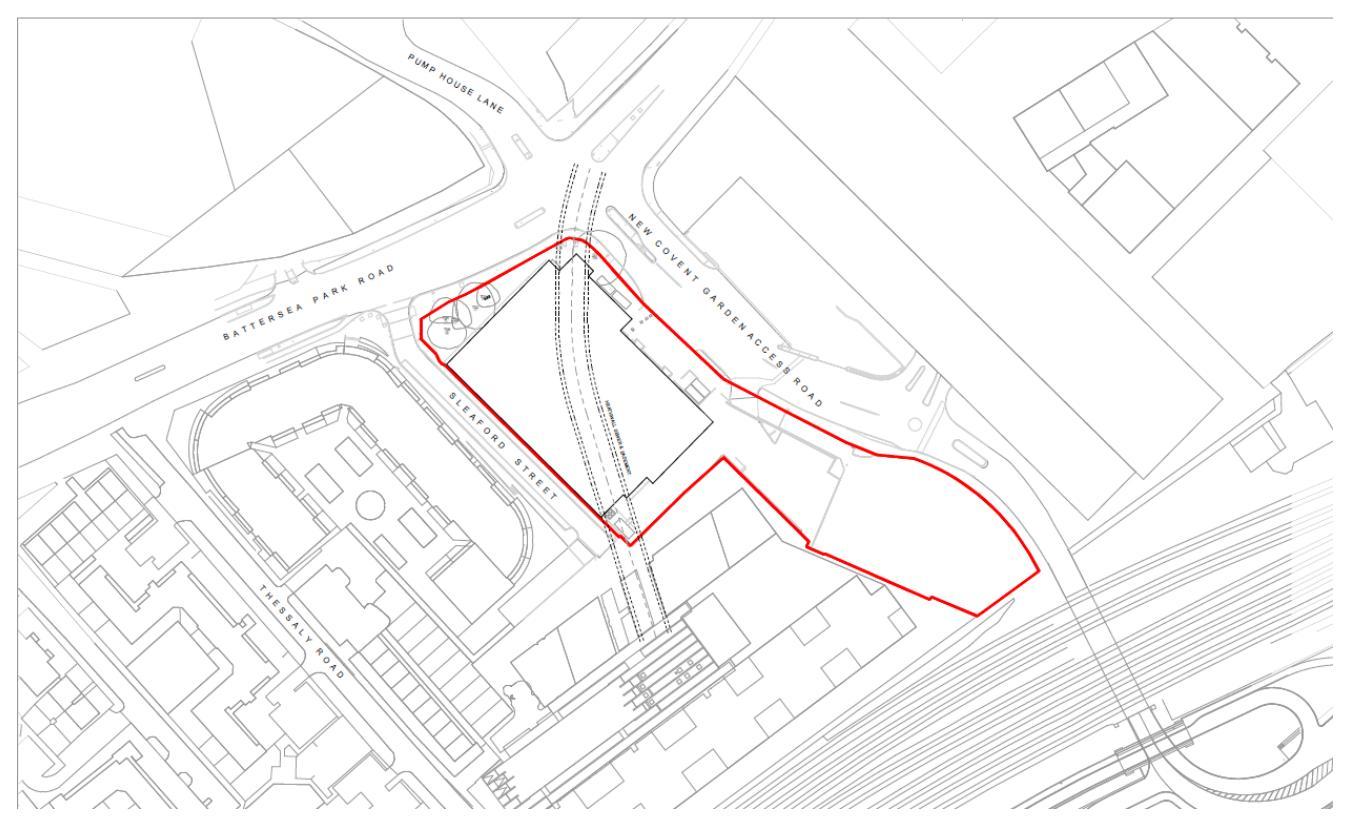
No detailed plans of the Booker Warehouse were provided, however site plans were available. The figure below shows the extent of the warehouse.

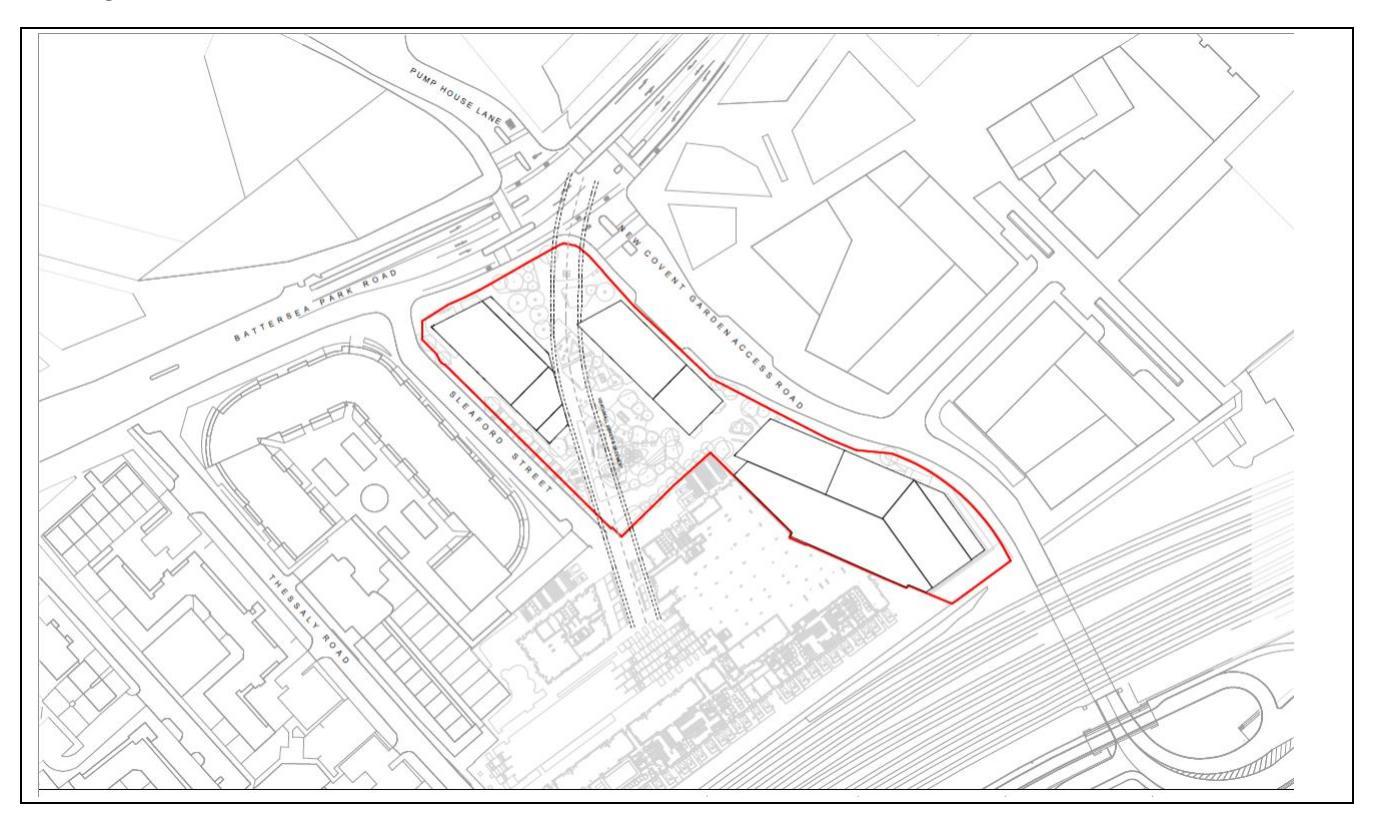
The figure below shows the extent of the new scheme.

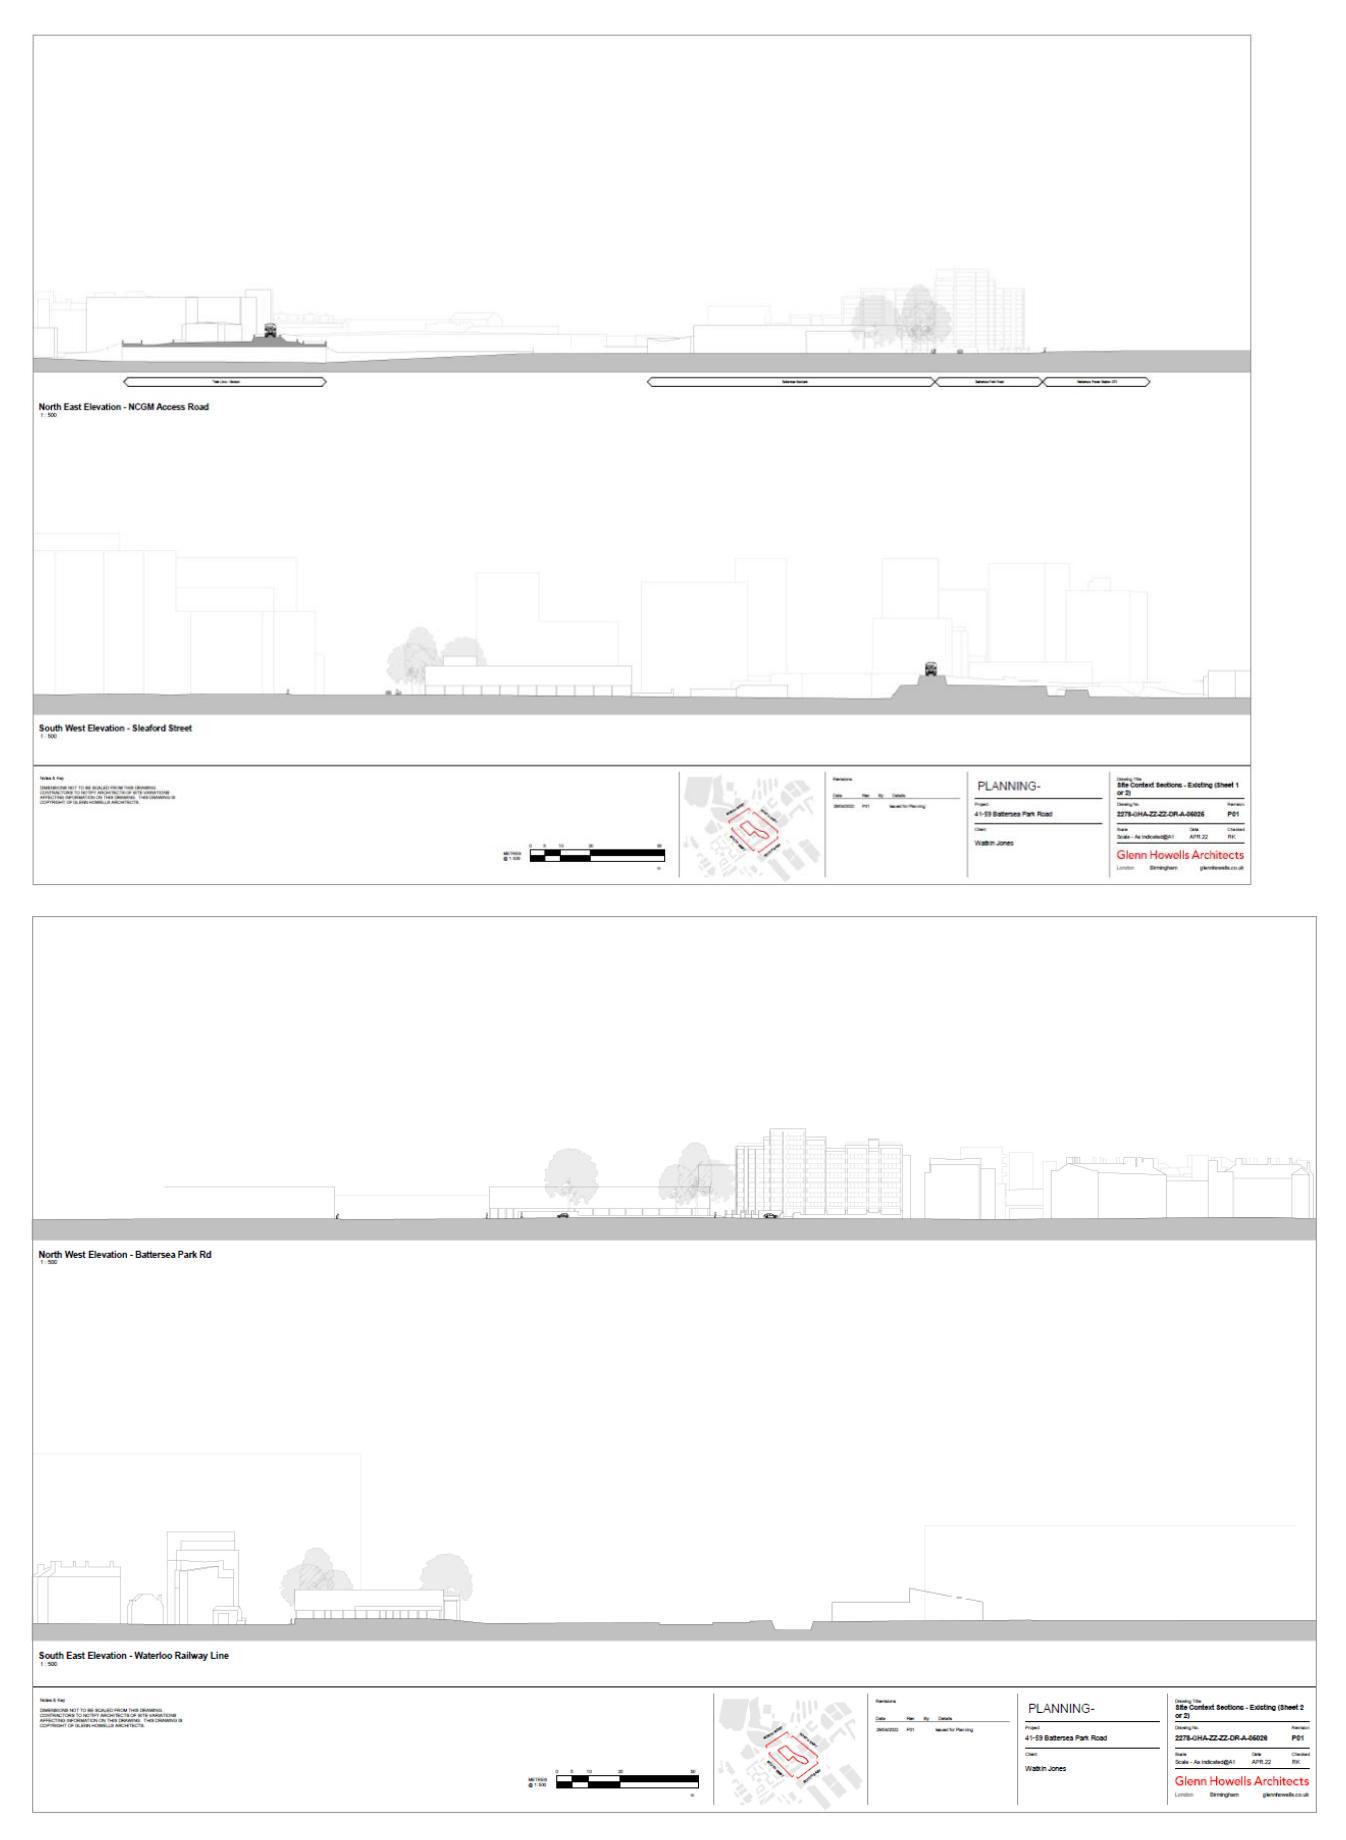
Elevations are also shown below of the existing building.

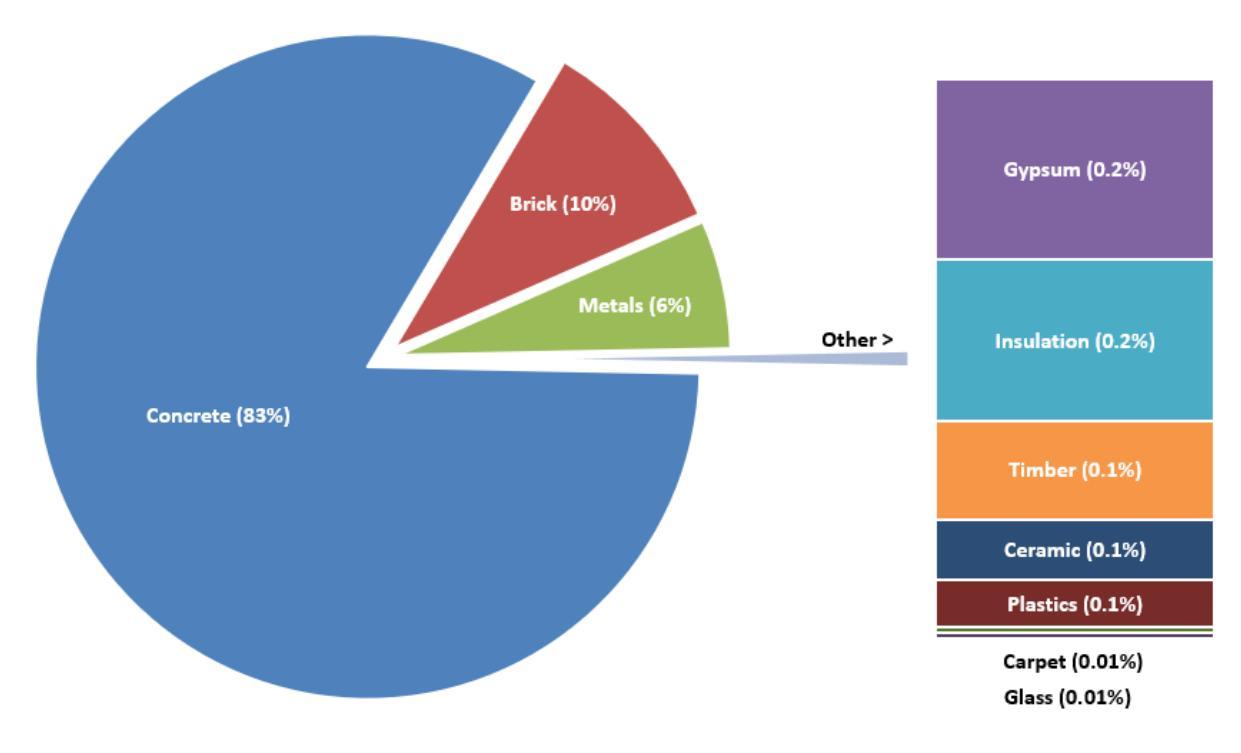
Chart 1: Summary of Key Demolition Products (KDP) by percentage weight

The estimated Key Demolition Products (KDP) by weight are Concrete (83%), Brick (10%), Metals (6%), Gypsum (0.2%), and Insulation (0.2%), with smaller amounts of Timber, Ceramic, Plastics and Carpet. Miscellaneous items and WEEE are also present although these have not all been quantified.

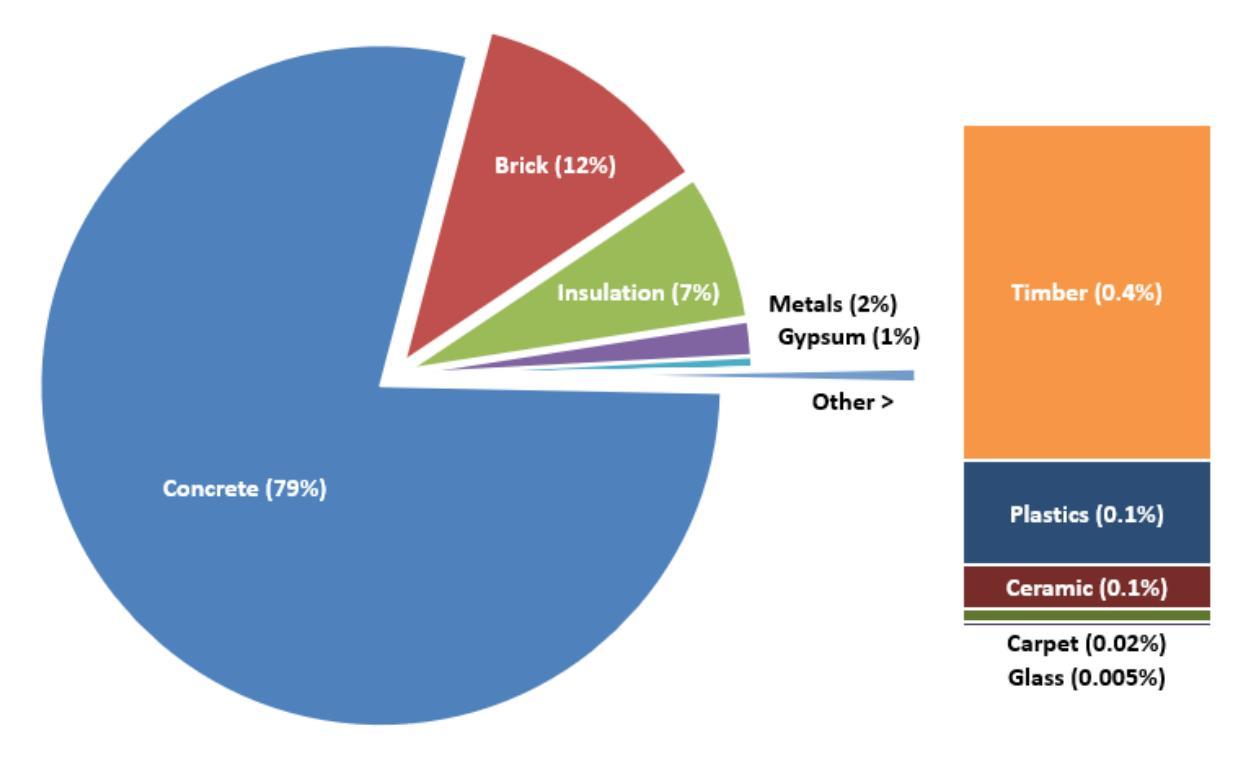
Chart 2: Summary of Key Demolition Products (KDP) by percentage volume

The largest KDPs by volume are Concrete (79%), Brick (12%), Insulation (7%), Metals (2%), and Gypsum (1%), with smaller amounts of Timber, Plastics, Ceramic and Carpet.
